**North American Society for Trenchless Technology (NASTT)
NASTT's 2016 No-Dig Show**

TM1-T1-02

Carbon FRP Breathes Life into 90-Years Old Riveted Steel Penstock

Mo Ehsani, PipeMedic, LLC, Tucson, AZ
Craig Hurley, Salt River Project, Phoenix, AZ
Joshua Ahumada, FRP Construction, LLC, Tucson, AZ

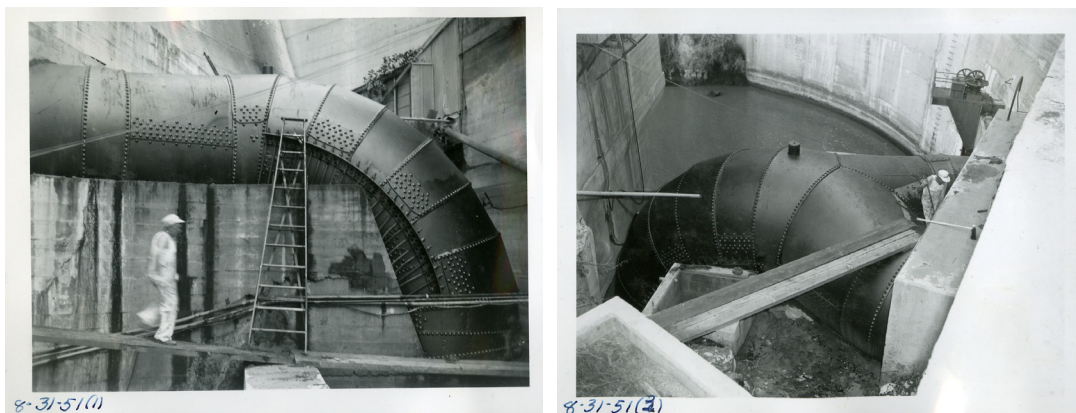
The penstock exterior has always been well maintained with appropriate coatings (Fig. 3). The interior of the penstock is lined with a coal tar coating for protection. The overall condition of the interior coating was unknown and routine inspections several years ago by SRP raised concerns of possible thinning of the penstock material. A consultant was

Fig. 3. Periodic inspection and maintenance of the exterior of the penstock – circa 1951.

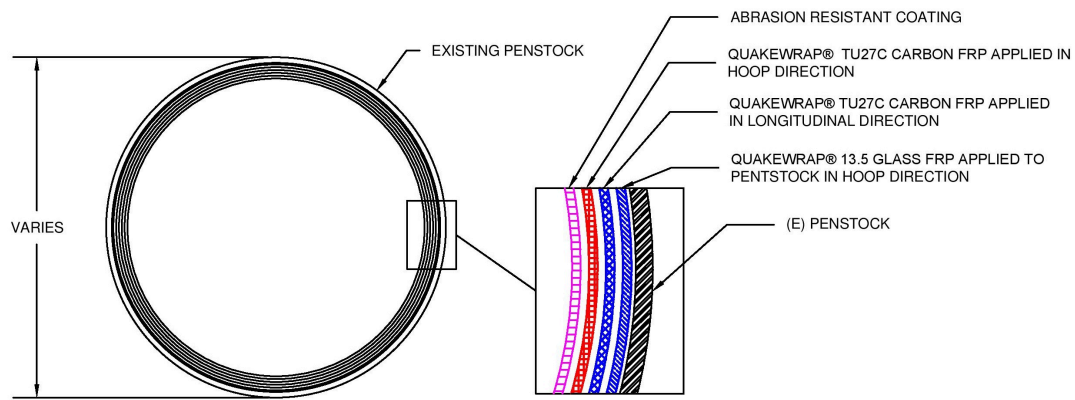
Fig. 5. Various layers of FRP and coatings applied to the penstock

In locations where excessive longitudinal stresses require strengthening of the pipe, layers of the same unidirectional carbon fabric can be applied along the axis of the pipe. In repair of steel structures with CFRP, care must be taken to avoid direct contact between the steel and carbon fibers which acting as dissimilar metals could result in galvanic corrosion. While the epoxy may provide adequate protection, a more conservative approach is to apply a layer of glass fabric as a dielectric barrier to the steel surface. This fabric will serve as a physical barrier to prevent direct contact between the carbon and steel. For this project, a layer of glass fabric was applied to all steel surfaces. Figure 5 shows various layers of reinforcement and coating applied to the penstock. Various layers of FRP and coatings applied to the interior surface of the penstock are shown in Figs. 5 and 6.

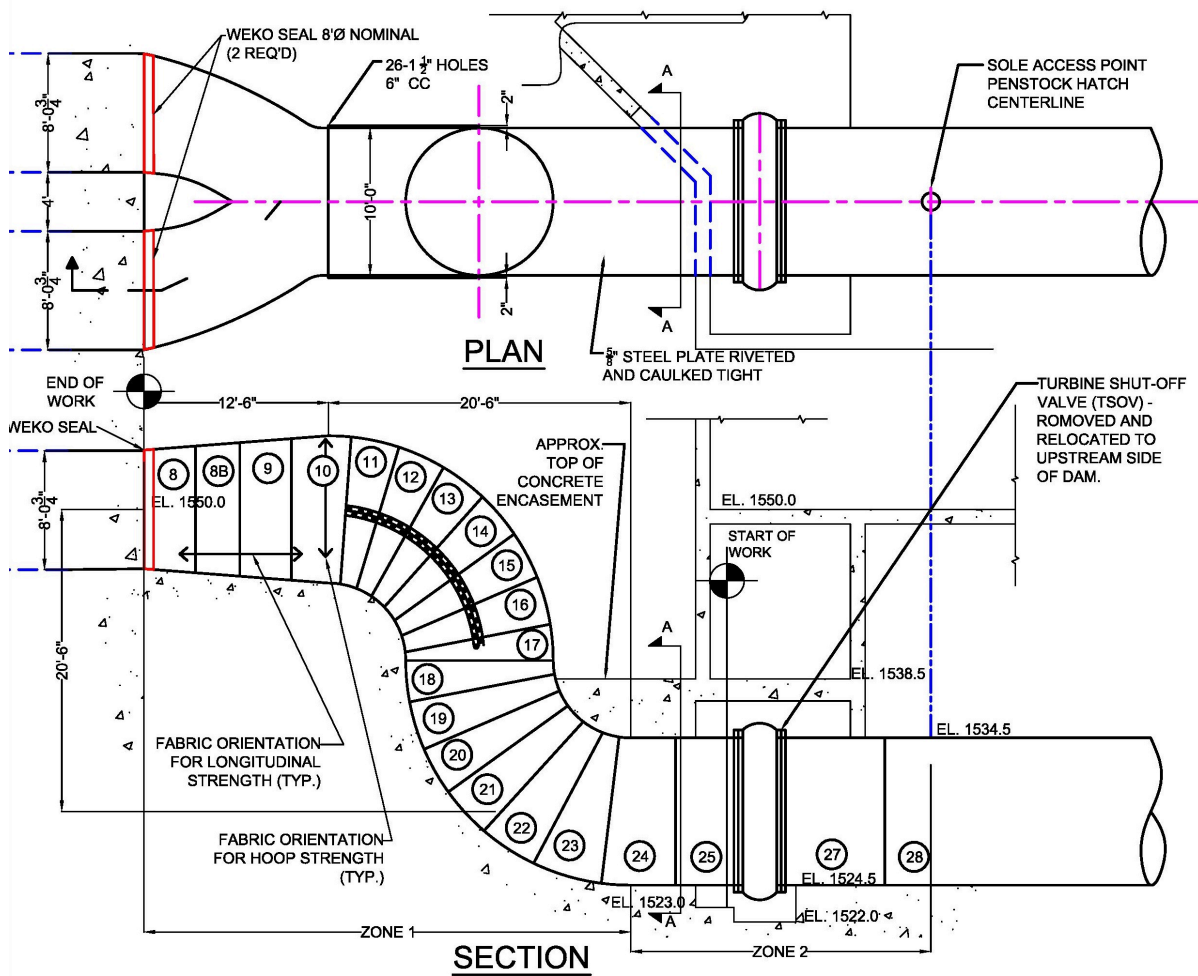
Fig. 6. Overall repair area

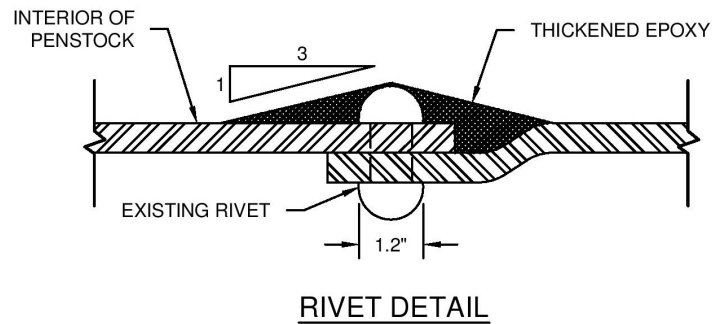
Fig. 8. Detail of preparation of the area around rivets prior to the application of CFRP.

In application of FRP attention must be paid to apply the fabric under a slight tension to avoid any kinks. Otherwise, when subjected to tension, the fabric will want to rid itself of the kinks first before resisting any tension. Similarly, sharp changes in curvature must be avoided. For this reason the areas around the rivets had to be filled with a mix of thickened epoxy. Such epoxy is very thixotropic and can be applied like a viscous paste. Figure 8 shows the detail for repair of riveted areas. The gentle slope produced by application of thickened epoxy ensures proper transfer of force.

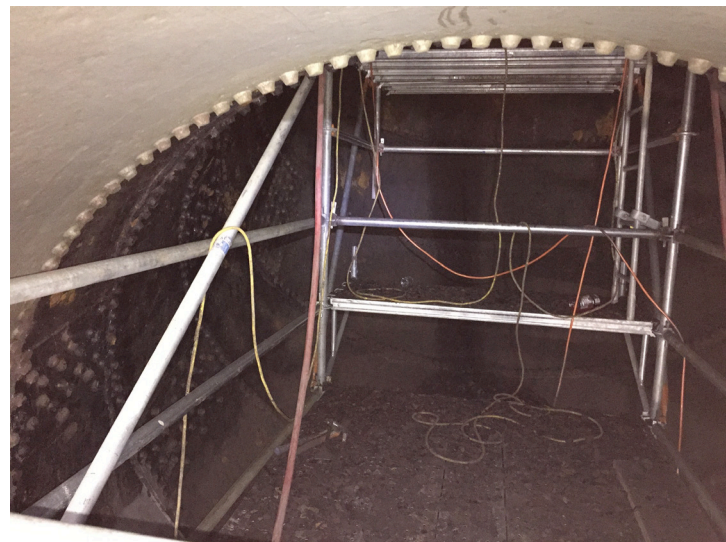
Fig. 9. Scaffolding set up inside the penstock.

Ring scaffolding was used so that individual pieces could be lowered into the penstock and assembled into a custom unit. The penstock itself had significant change in elevation. Scaffolding was set up in the lower pipe that would reach the entire circumference of the penstock by hand (Fig. 9).

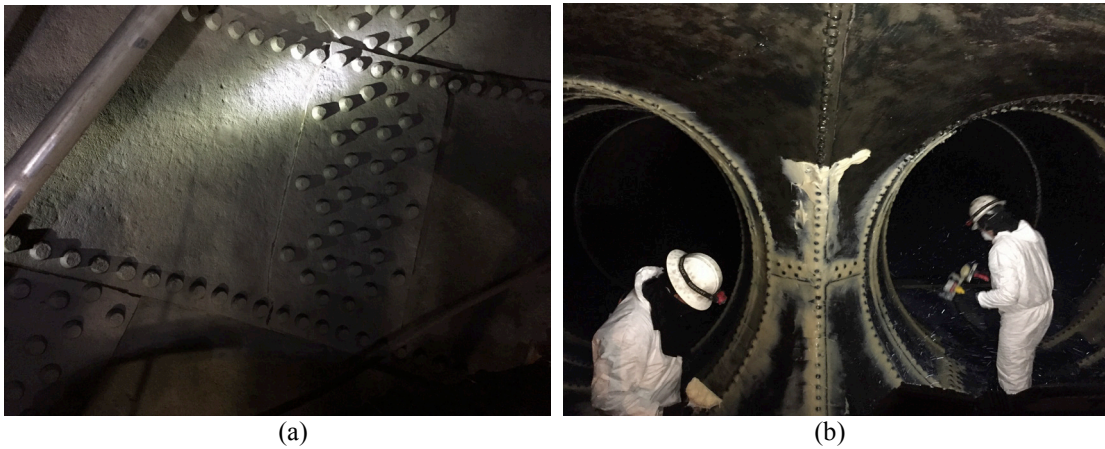
A significant effort was spent to cover the thousands of rivets in the penstock. These rivets protruded from the pipe surface longer than previously assumed. A mix of thickened epoxy was troweled over the rivets to provide a gradual transition to the pipe interior surface. In some cases, chopped glass fibers was also blended with the thickened epoxy prior to

Fig. 10. (a) close-up of the rivets inside the pipe and (b) coating the rivets with thickened epoxy.

dimension of the rivet head was substantially larger than estimated. The original design to coat with epoxy was still determined to be valid but it is possible another option of having prefabricated molds to cover the rivets to ensure a uniform coating/feathering over the rivets may have saved some repair time. It would have been beneficial to have had an inspection of the penstock performed by the personnel who were involved with the project before the actual installation outage to make sure the most cost effective installation procedure was identified.

application. Figure 10 shows some of the rivets and the crew applying thickened epoxy in the area. Once the surface was completely prepared, the first layer of glass fabric was saturated with resin and applied to cover the entire interior surface of the penstock.

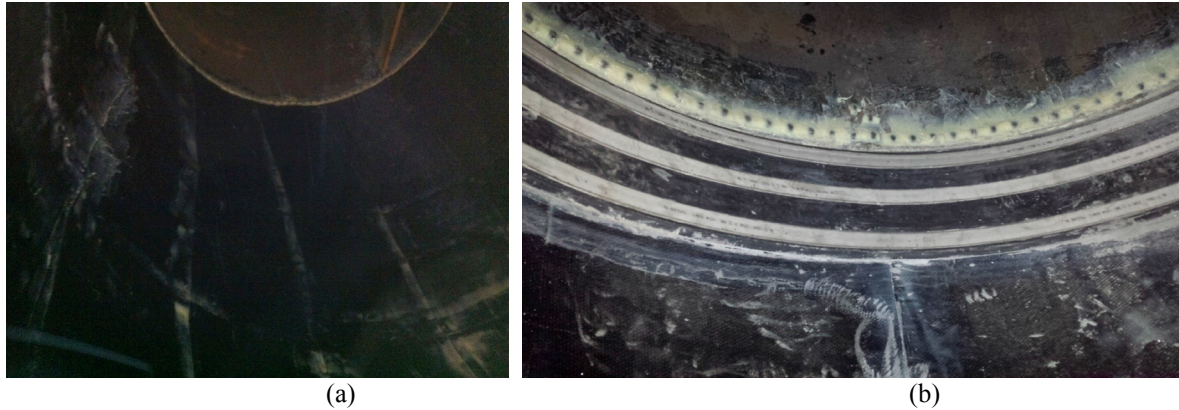
Fig. 11. (a) Repaired penstock prior to application of topcoat and (b) at termination point showing Weko Seal

As the layers of fabric are installed, it may be necessary to apply an additional layer of thickened epoxy between the fabric layers. This is necessary especially in overhead applications to prevent the saturated fabric from sliding before the epoxy cures. The overlapping joints and edge of the fabric must also be trimmed and coated with epoxy (Fig. 11a). Once all fabric layers were installed, the leading edge in each of the 96-inch pipes was protected by applying a Weko seal. As discussed earlier, this seal presses the fabric firmly against the host pipe, eliminating the possibility of water reaching behind the CFRP liner (Fig. 11b).

As the last step of construction, the entire installation was coated with a 40-mil thick top coat for abrasion resistance. This coating was applied using a pneumatic pump. The repairs required a total of 11,000 square feet of FRP fabrics to be installed over the 60-ft long section of the penstock. The work was completed with a single 8-man crew within the allotted 3-week time frame.
