**North American Society for Trenchless Technology (NASTT)
NASTT's 2018 No-Dig Show**

**Is it Round, Square or Oval:
Repair of a Culvert with Multiple Cross Sections**

Mo Ehsani, PhD, PE, President QuakeWrap, Inc. and Professor Emeritus of Civil Eng. U. of Arizona, Tucson, AZ Mo@QuakeWrap.com ,

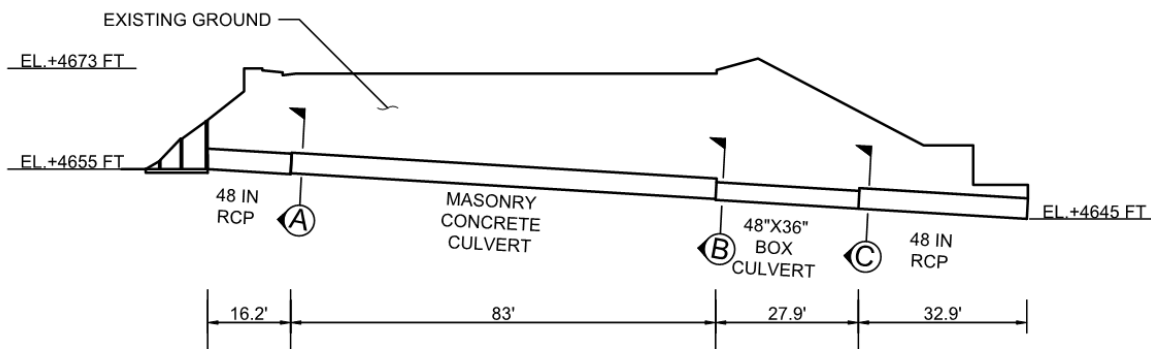
As the population of the city grew over the years, Sunnyside Avenue was widened, and it is believed that these expansion projects are the source of different culvert cross sections being used on this site (Fig. 3). The original project is estimated to have been built pre-1900s and it included an 83-ft long masonry/concrete (m/c) oval-shaped culvert 48-in. wide by 48-in. high.

The first expansion is estimated to have taken place post-1940 and resulted in adding a 28-ft long segment of a reinforced concrete box culvert 48-in. wide by 36-in. high. The next widening project took place around 1980 and the culvert was extended from both ends utilizing 48-in. diameter reinforced concrete pipe. This resulted in 16 feet of new culvert on the north end and nearly 33 feet on the south end.

Fig. 3. Elevation view showing locations for different shaped culverts.

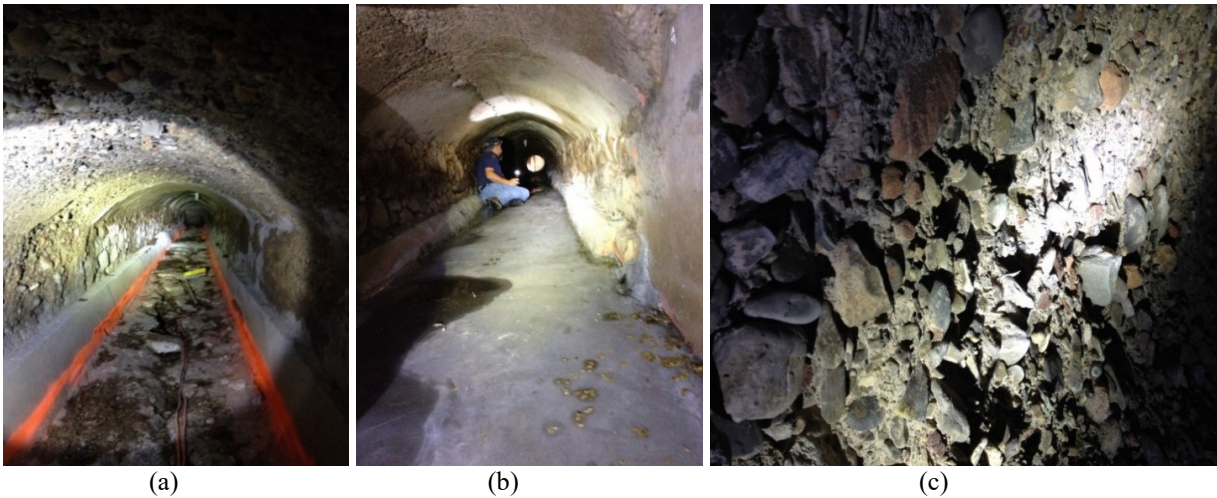
Prior to rehabilitation of the culvert, the condition of the m/c section was in the worst condition, with the channel of the flow line being completely eroded, visible aggregate throughout the conduit, and a large crack throughout the crown of the pipe.

Phase I of the culvert rehabilitation was completed successfully in the spring of 2016 and consisted of installing 6 inches of concrete with wire mesh to the culvert flow line of the m/c section of culvert as shown in Fig 4(b). Rehabilitation of the remaining deteriorated portions of the m/c culvert shown in Fig. 4(c), and the box culvert and reinforced concrete pipes were all parts of the repairs conducted in 2017 that are being reported here.

Fig. 4. The original m/c culvert: (a) damaged invert; (b) repaired in 2016, and (c) deteriorated interior surface

As stated earlier, the most severely damaged section of this culvert was the m/c which was part of the original construction. The invert of this region was lined with concrete a year earlier and remained in good condition. The regions near the spring line and crown that were deteriorated were repaired with gunite. A 4-in. X 4-in. steel mesh was installed on the wall prior to the application of gunite.

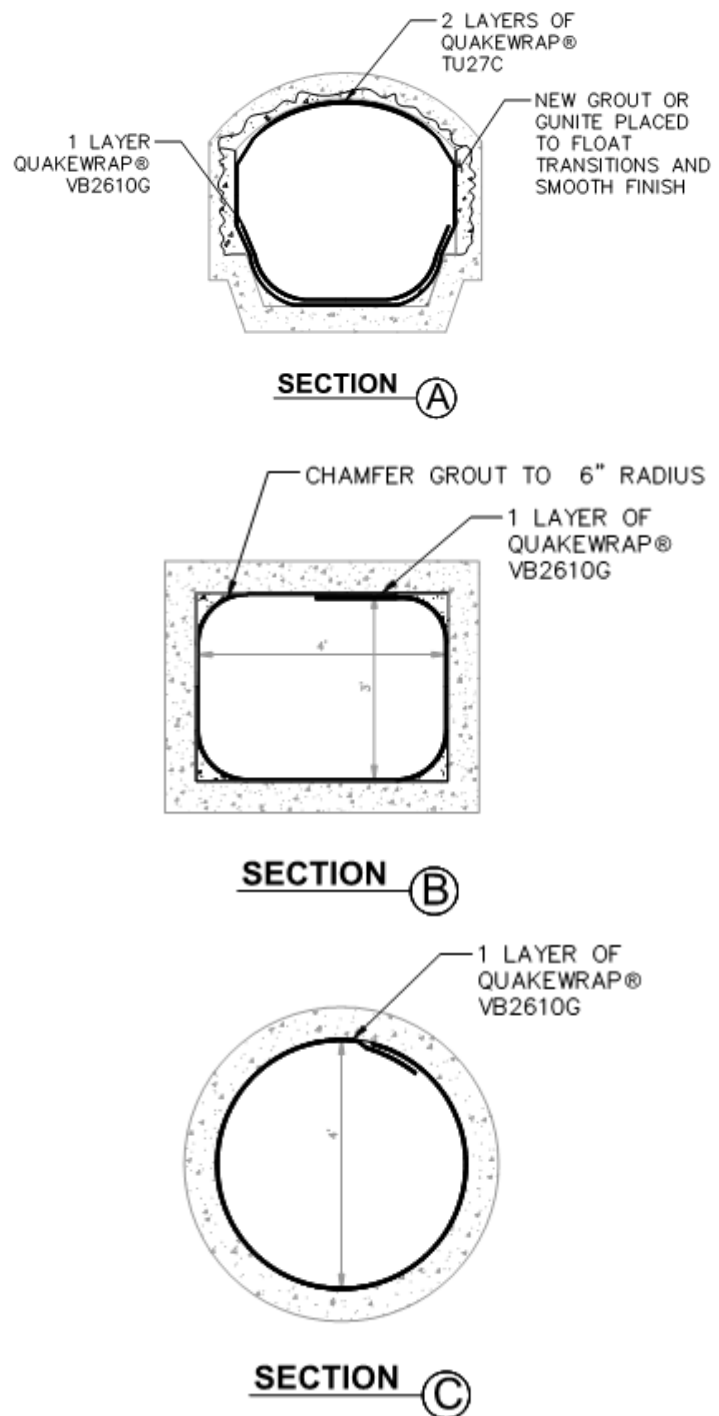
Fig. 5. Design of retrofit for different sections of the culvert

The solution provided for this project is shown in Fig. 5. The cross sections correspond to those shown in Fig. 3.

FRP reinforcement included one layer of a unidirectional carbon fabric in the hoop direction, and another layer of the same fabric in the longitudinal direction. In addition, a single layer of biaxial glass FRP was applied to the invert section of the culvert up to the spring line. These fabrics were properly overlapped to develop their full strength and to prevent intrusion of water between the joints.

The walls of the box culvert and the circular reinforced concrete pipe were in fairly good condition. These segments were repaired by application of a single layer of biaxial glass fabric over the entire interior surface.

One of the advantages of the wet layup FRP is its ability to conform to any shape onsite. However, care must be taken near the corners to ensure that sharp angles do not cause damage to the fibers within the fabric. Consequently, all transition points from oval to box to circular were hand patched with cementitious grout or gunite to achieve a smooth transition surface.

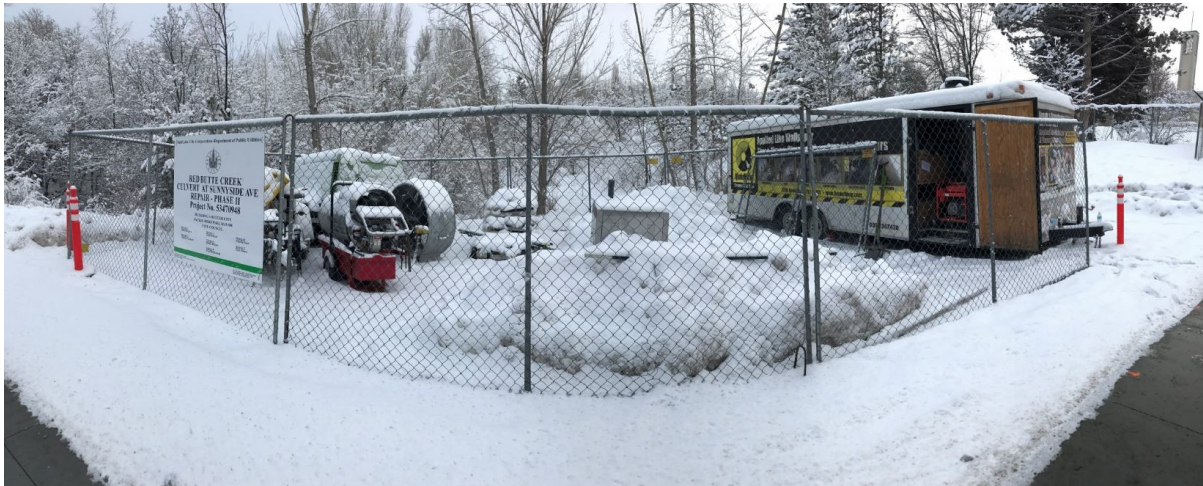
The construction started on January 23, 2017. As in most construction projects, unforeseen conditions caused by inclement weather added to the challenges of this project. The site was covered in nearly 2 feet of snow (Fig. 6) and the crew could not move the equipment and materials into the culvert due to limited access. A skid steer was used to clear the snow and to provide access to the culvert.

Fig. 6. Snow covered site made access to the culvert difficult

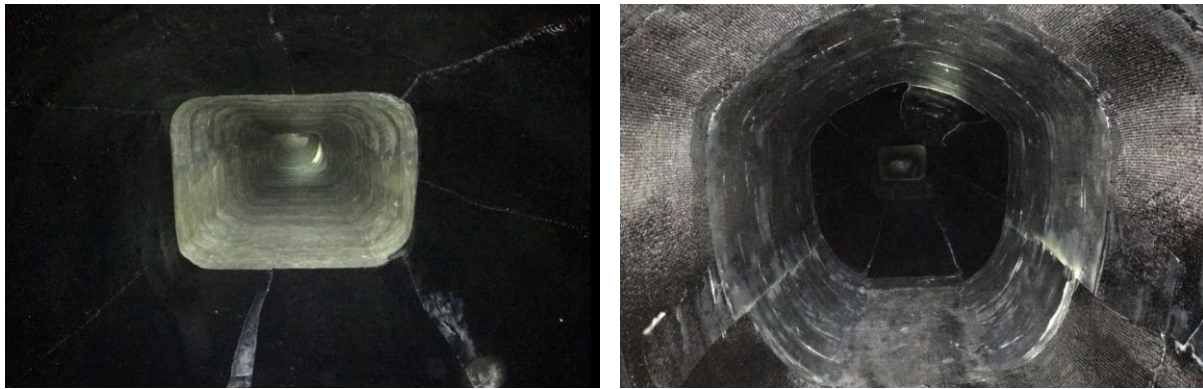
Fig. 7. Finished culvert after the installation of FRP

The various layers of carbon and glass fabric as described earlier were saturated in the field using a saturating machine. The culvert surface was cleaned and primed with a thin coat of epoxy. The resin-saturated bands of fabric were bonded to the interior surface of the culvert as described in the design section above. When applying FRP attention must be paid to apply the fabric under a slight tension to avoid any kinks. Otherwise, when subjected to tension, the fabric will attempt to rid itself of the kinks first before resisting any tension. Similarly, sharp changes in curvature must be avoided. For this reason, the transition areas were filled with gunite to provide a smooth surface devoid of sharp edges and corners. A diesel forced air heater was set up outside the culvert and provided heater air flow through the culvert. In addition to keeping the crew more comfortable, the warm air helps with faster curing of the epoxy.

The crew must also ensure that all points of the FRP remain in contact with the substrate surface and no air is entrapped below the FRP. The design guidelines provided ACI Committee 440 offer guidance for the acceptable size of air bubbles and techniques for fixing such voids. The edges of the FRP layers must also be properly finished with an epoxy paste. Figure 7 shows the finished surface of the culvert at various locations. A time-lapsed short video showing the crew installing the FRP inside the culvert is available here (<http://tinyurl.com/y83ujt3j>).

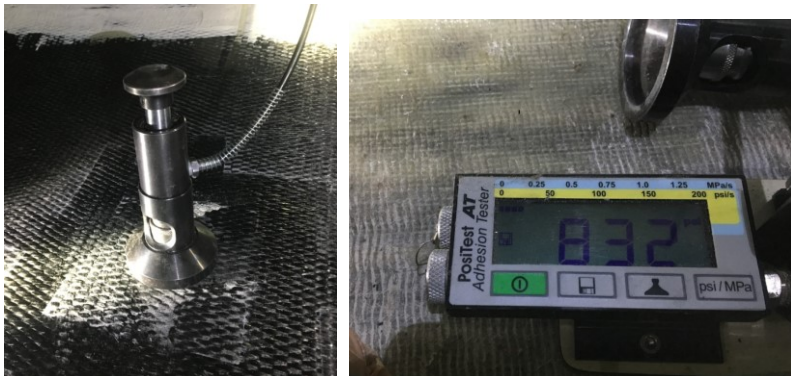
Successful application of wet layup FRP is critically dependent on the good bond developed between the FRP and the surface of the host pipe. ACI 440 guidelines specify a minimum bond strength of 200 psi. These pull-off adhesion tests are performed by bonding a circular tab to the surface of the concrete and FRP (Fig. 8) and subjecting it to direct tension (ASTM D7234). All pull tests on the concrete surface exceeded the minimum 200 psi values, and the bond tests on FRP were higher than 800 psi (Fig. 8), indicating the excellent bond strength of the epoxy.

Fig. 8. Pull-off adhesion test apparatus for ASTM D7234
