## **Repair of Corrosion-Damaged Substation Structures**

*Mo Ehsani, PhD, PE, F.ASCE, Prof. Emeritus of Civil Eng., U. of AZ and President,  
QuakeWrap, Inc. [Mo@QuakeWrap.com](mailto:Mo@QuakeWrap.com), and  
Gannon McGhee, PE, Civil Engineer IV, Tucson Electric Power Company  
[gmcghee@tep.com](mailto:gmcghee@tep.com)*

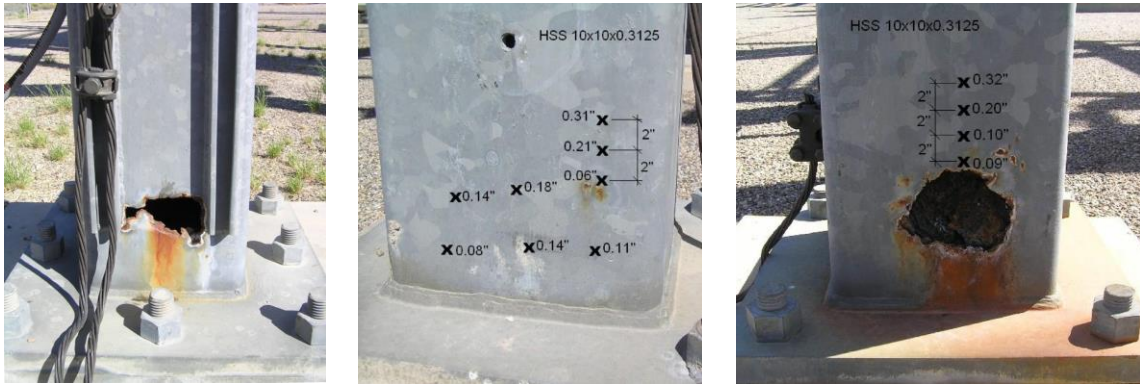
During an inspection at one of Tucson Electric Power's substations, extensive corrosion was discovered on many of the substation support columns. Based on a visual inspection, it seemed that the corrosion had begun on the inside of the column wall meaning that the damage was potentially much worse than it appeared. An ultrasonic thickness gauge was used to determine the steel thickness adjacent to the visible damage. Measurements along the height of the columns indicated that the loss of wall thickness was more severe closer to the base of the column (Fig. 1). These investigations also revealed that in many cases

the majority of the structural damage was on the inside of the square columns with little or no visible damage from the outside.

Fig. 1. Typical steel columns damaged by corrosion and measured wall thickness

Since the majority of the structural damage was found to be on the inside of the square columns, it was concluded that the damage is most likely the result of deficiencies during the galvanizing process. It is likely that the acid bath was not properly drained from the columns during the prepping stage causing the inside of the square columns near the base not to be galvanized properly. In addition, during the installation of these columns, grout had been placed between the base plate and the foundation. This caused rainwater to be trapped inside the structure, which accelerated the corrosion process.

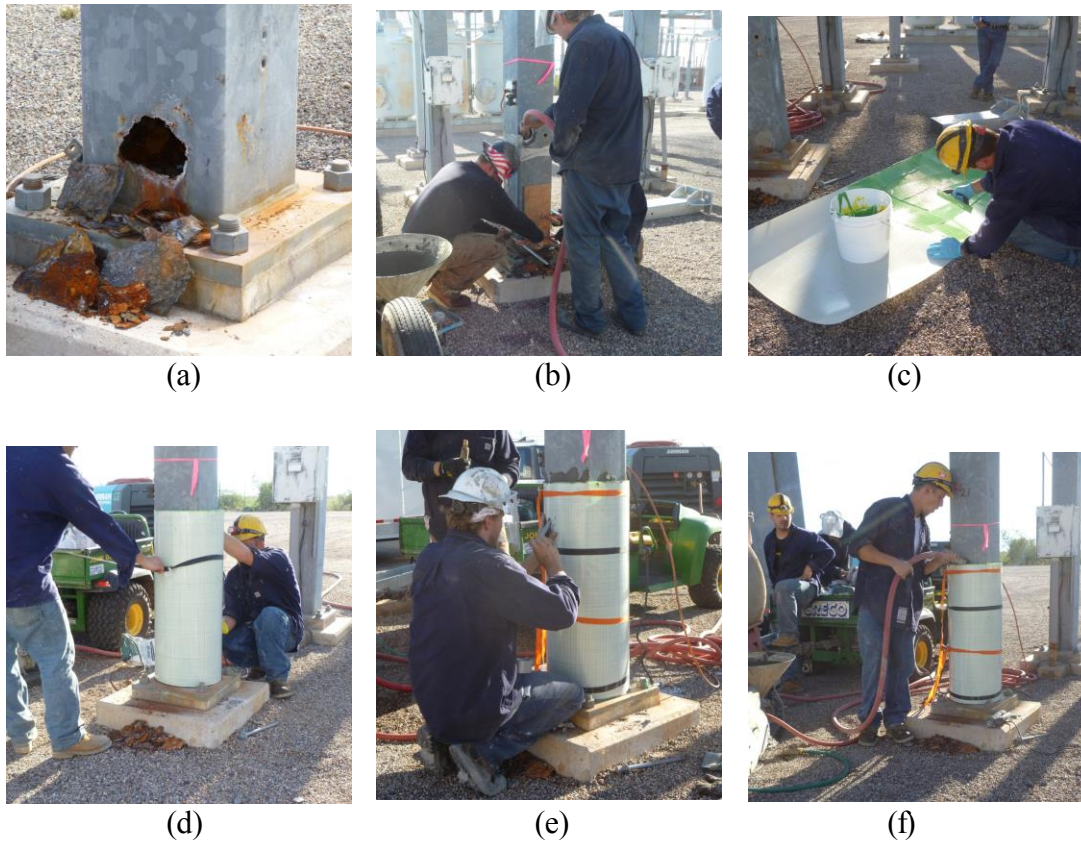
Fig. 6. Various stages of repair of corroded steel columns

The repair of the columns with laminates was aimed at strengthening the lower 3 feet of the structures. First, the corroded material that had separated from the inside of the structure was removed and the column was cleaned of any rust (Fig. 6a).

An access port about 3 inches in diameter was cut at an elevation of 33 inches from the base. The openings were temporarily sealed with plywood and clamps. A non-shrink high-strength grout was mixed and pumped into the structure from the access port (Fig. 6b). Four No. 5 U-shaped reinforcing bars were welded to the base plate; these bars were primarily for enhanced flexural capacity of the structure.

Due to its dielectric properties, a glass laminate with tensile strength of 62000 psi and thickness of 0.026 inch was used. A 3-foot wide x 8.5-foot long piece of laminate was used for each structure (Fig. 6c). A special two-component epoxy was mixed in the field and applied to an approximately 5-foot long section of the laminate. The mixed epoxy has a paste-like consistency and is applied with a trowel to a thickness of 20-30 mil (Fig. 6c). The laminate is then wrapped loosely around the structure to create a two-ply shell (Fig. 6d). The 8.5-foot length of the laminate allows creation of a two-ply 15-inch diameter shell with 8 inches of overlap beyond the starting point. At this stage, before the epoxy cures, ratchet straps must be used to hold the shell in the desired shape.

A 1-inch diameter PVC drain pipe was installed to make sure no rainwater will accumulate inside the structure (Fig. 6e). The bottom edge of the jacket was sealed with tape atop the base plate.

The annular space between the jacket and the steel column was also filled with the same non-shrink grout (Fig. 6f). Consolidation of the grout was completed with a small vibrator and the top of the grout was finished with a trowel. Before the grout sets, the hydrostatic pressure from the grout pushes the inner layer of the jacket outward against the outer layer and forces the two plies of the laminate to be tightly pressed against each other.
