ASCE Innovation Award Winner: Sandwich Construction Carbon FRP Pipe

Mo Ehsani, PhD, PE, FASCE

ABSTRACT

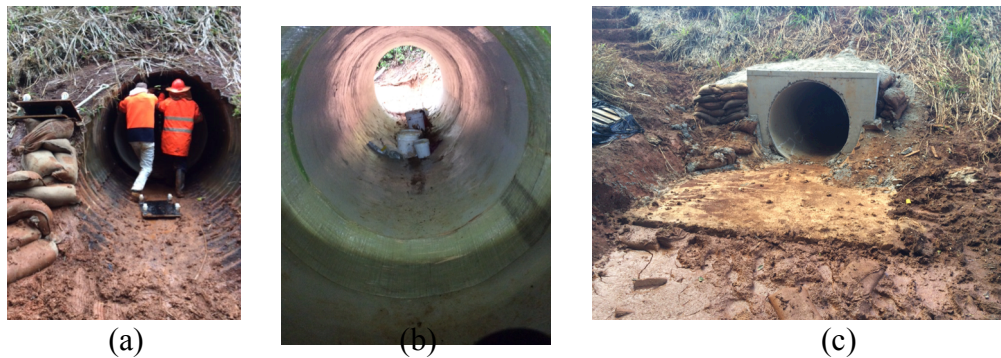
The original plan for installation was to support the pipe segments on casters and push them into the culvert. However, the corrugated geometry of the culvert would not allow for easy movement of the casters. Consequently, the caster trolleys were positioned upside down along the length of the culvert (Fig. 4a). Each segment of SC pipe weighs only about 1000 pounds; these light segments were placed over the casters and pushed by hand into their final position. The light weight of the pipe allowed this operation to be completed with only two men pushing the pipe in place (Fig. 4a). Short pieces of PVC pipe were wedged along the sides and top of the culvert to maintain the annular space between the culvert and SC pipe.

Fig. 4. (a) Caster trolleys inside the culvert allowed pushing lightweight StiffPipe® segments by hand into the culvert; (b) joining of segments with wet layup; (c) finished project

Once the proper alignment of all 4 SC pipe segments was achieved the ends of these pipes were connected together using a wet layup system. As shown in Fig. 4b, a 12-in. wide band of VB26G glass fabric was saturated with resin and applied along the joint in the hoop direction. Grouting operations were affected by coring through the roadway. As shown in Fig. 4c, cores were drilled in the roadway surface, penetrating through the CMP culvert and a cementitious grout was introduced to fill the annular space between the culvert and the liner. The headwalls at both ends of the culvert were formed and built with concrete (Fig. 4c). A video detailing this project is available online (<https://goo.gl/eCyjH>).

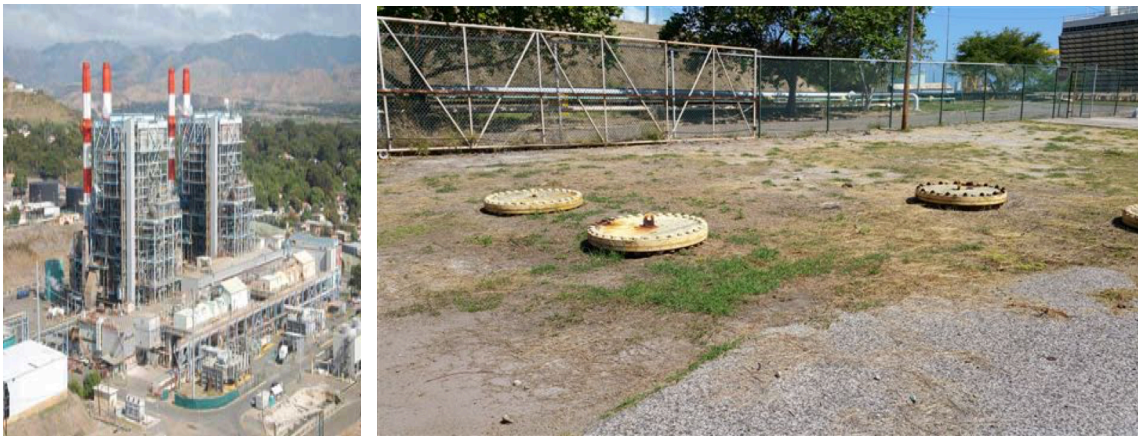
Fig. 5. Aerial view of Aguirre Power Plant (Salinas, PR) and typical pipe risers and lids

In 2015, severe corrosion in one of these riser pipes resulted in the steel cover dislodging under pressure. The riser pipe lid was thrown nearly 100 feet away and luckily did not injure anyone. This led to an inspection of all riser pipes by the plant management. During this inspection it was determined that several of these risers exhibited various degrees of corrosion near the ground level. As a result, it was decided to repair the upper 4 feet of 29 riser pipes.

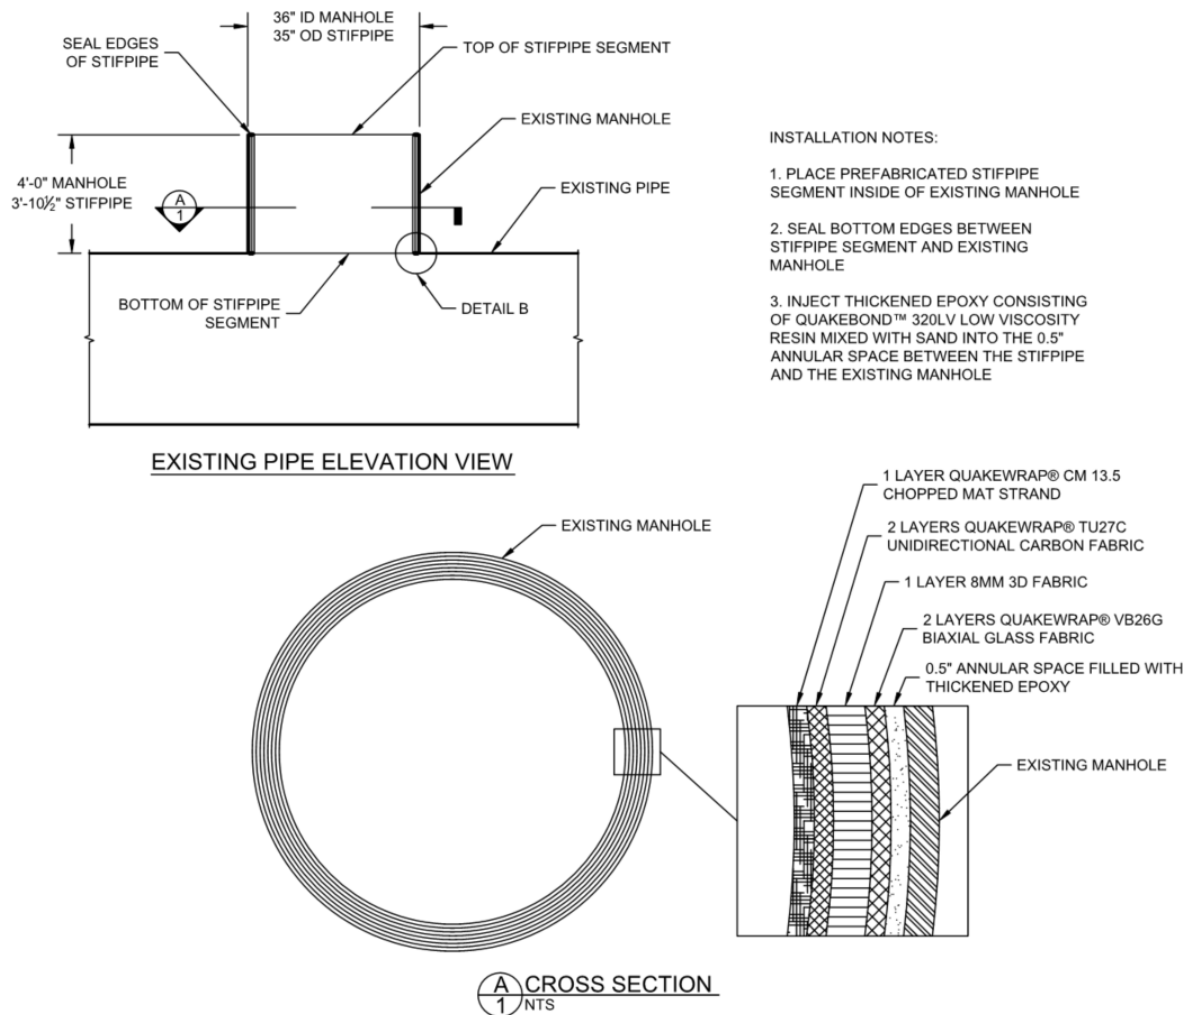
For this project, the pipe consisted of the following layers from inside to the outside of the wall (Fig. 6):

- 1 Layer of chopped strand mat
- 2 Layers of TU27C
- 1 0.31-inch spacer sheet
- 2 Layers of VB26G

Fig. 6. Details of the SC carbon FRP pipe design for this project

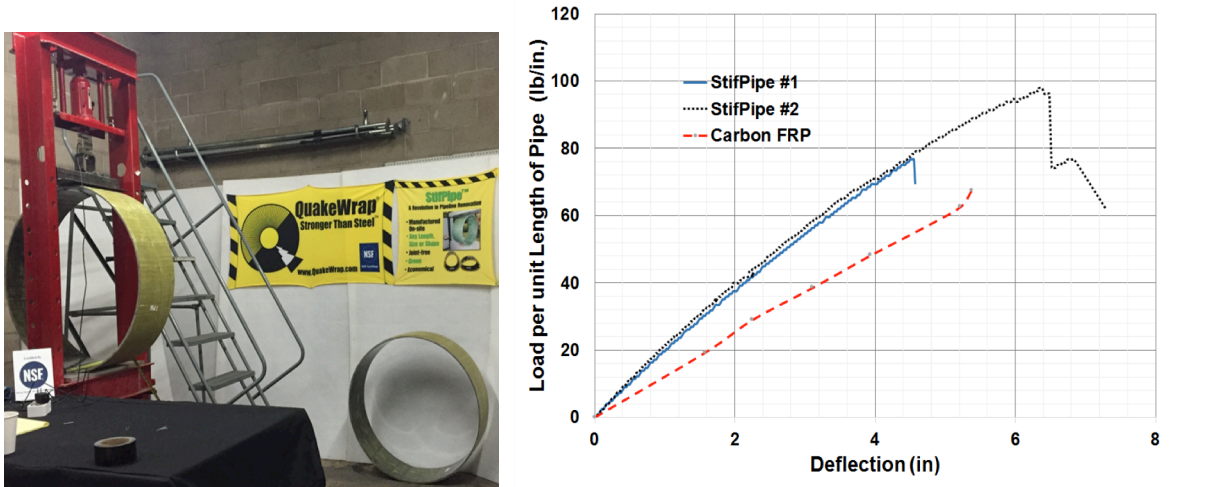
Testing. As part of quality control and to verify the validity of design assumptions, two pieces of the pipes were randomly selected from the production line and were tested under parallel plate testing according to ASTM D2412. As shown in Fig. 8, the behavior of the pipes is linear to failure. Furthermore, the load-deformation characteristics of both samples were nearly identical in the elastic range, indicating high quality of the construction. The average ring stiffness for the pipes for various deflection levels are listed in Table 2. These values are comparable to pipes made with HDPE or PVC and can be used for the design of the pipe subjected to external compressive loads.

The dashed graph in Fig. 8 represents the results of an earlier test that was conducted for a different project (Ehsani 2102). In that case, a 36-inch diameter pipe with 6 layers of VU18C carbon FRP (without any spacer sheets) was tested. It is clear that the stiffness of SC carbon FRP pipe that takes advantage of the sandwich construction and a spacer sheet, is much higher than the plain carbon FRP pipe, even though the SC carbon FRP pipe was built with only two layers of carbon FRP. This data proves the economic and strength advantages of the SC pipe compared to the conventional wet layup solution that has been used to date.

Fig. 8. Sample of SC carbon FRP pipe being tested and Load-Deflection results

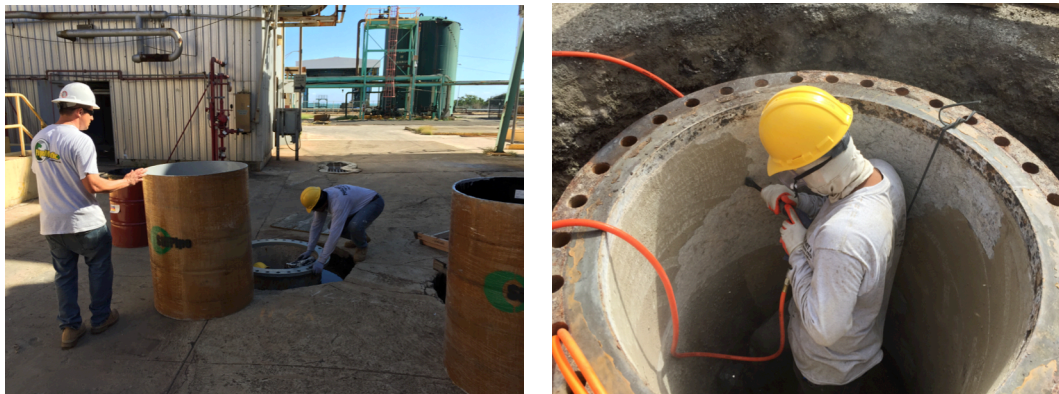
Field installation. The pipe segments were delivered to the jobsite and positioned next to the various riser pipes. A layer of the cementitious coating and laitance in the risers about 0.25 inch (6mm) was mechanically removed (Fig. 9) near the top 48 inch (1200 mm) of the riser; this created a horizontal ring/lip that would help support the PM carbon FRP pipe in place.

Fig .9. SC carbon FRP pipe segments placed by riser pipe and removing laitance from the interior surface of the pipe.

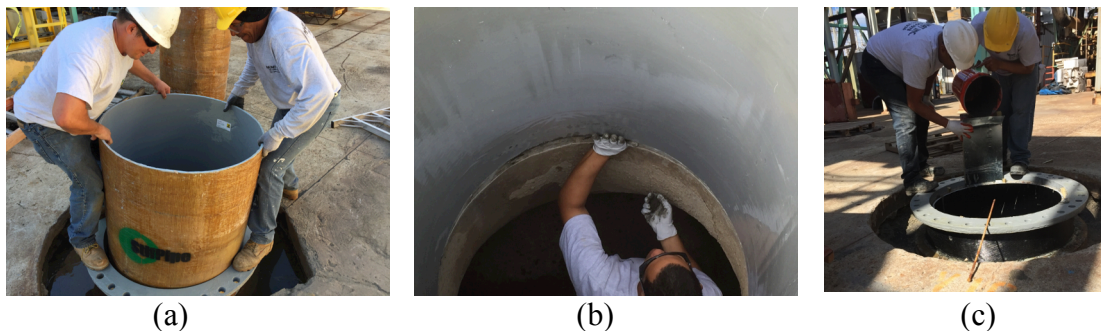
Fig 10. Installation process; (a) lowering of SC carbon FRP pipe into host pipe by hand, (b) sealing the bottom of the annular space, and (c) filling the annular space with grout.

The lightweight pipes could be easily lifted by workers and lowered into the host pipe (See Fig. 10a). An epoxy paste mixed with sand was used to seal the lower elevation of the annular space (Fig. 10b). An epoxy grout mix was placed in the annular space between the host pipe and SC carbon FRP pipe (Fig. 10c).

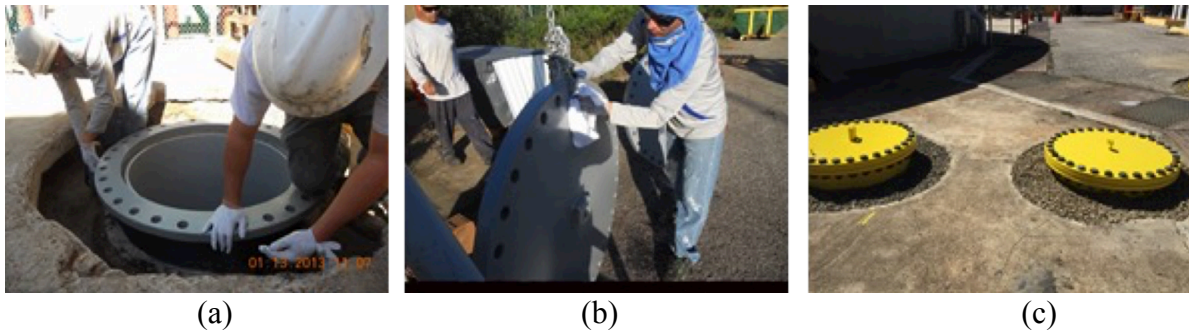
The risers had also experienced corrosion from the outside over a height of about 9 inches (230 mm) below the grade. As a part of this project, the outside of the riser pipes were also repaired. The soil around the riser was removed to expose the pipe.

The steel lids of the risers were also showing signs of pitting and corrosion. As a part of this renovation project, the lids were sandblasted to get rid of any corrosion. The lids were primed and coated with an epoxy (Fig. 11b) and reinstalled using new bolts (Fig. 11c). A video detailing this project is available online (<http://goo.gl/OBIVre>).

Fig. 11. Additional repairs included: (a) strengthening the outside of the pipe with carbon FRP, (b) epoxy coating the lids, and (c) installing the lids with new bolts.

A 9-inch (230 mm) wide band of TU27C carbon fabric was saturated with epoxy and wrapped twice around the exterior of the riser (See Fig. 11a). In addition to providing hoop strength and restoring the loss of capacity due to corrosion of steel, the FRP will serve as an impervious membrane that will keep oxygen and moisture away from the pipe. Because oxygen is the fuel for the corrosion process, eliminating oxygen will significantly reduce the corrosion rate.
