**North American Society for Trenchless Technology (NASTT)
NASTT's 2016 No-Dig Show**

TM1-T1-02

Carbon FRP Breathes Life into 90-Years Old Riveted Steel Penstock

Mo Ehsani, PipeMedic, LLC, Tucson, AZ
Craig Hurley, Salt River Project, Phoenix, AZ
Joshua Ahumada, FRP Construction, LLC, Tucson, AZ

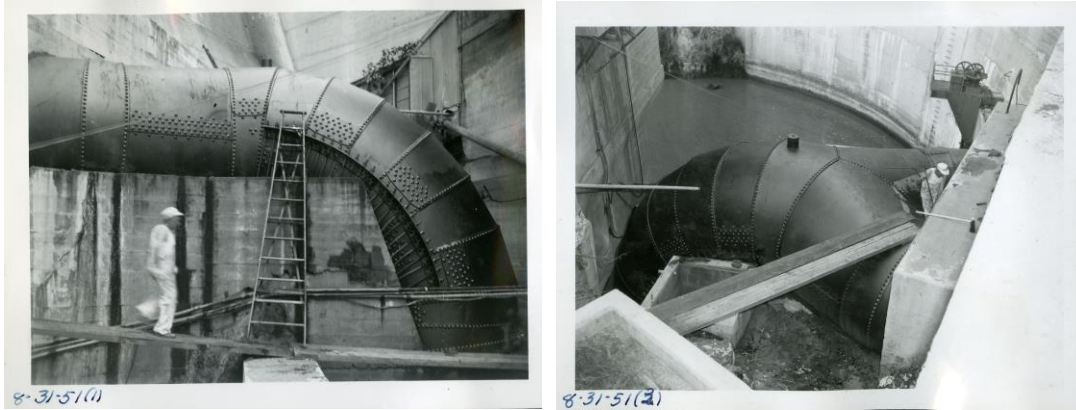
The penstock exterior has always been well maintained with appropriate coatings (Fig. 3). The interior of the penstock is lined with a coal tar coating for protection. The overall condition of the interior coating was unknown and routine inspections several years ago by SRP raised concerns of possible thinning of the penstock material. A consultant was

Fig. 3. Periodic inspection and maintenance of the exterior of the penstock – circa 1951.

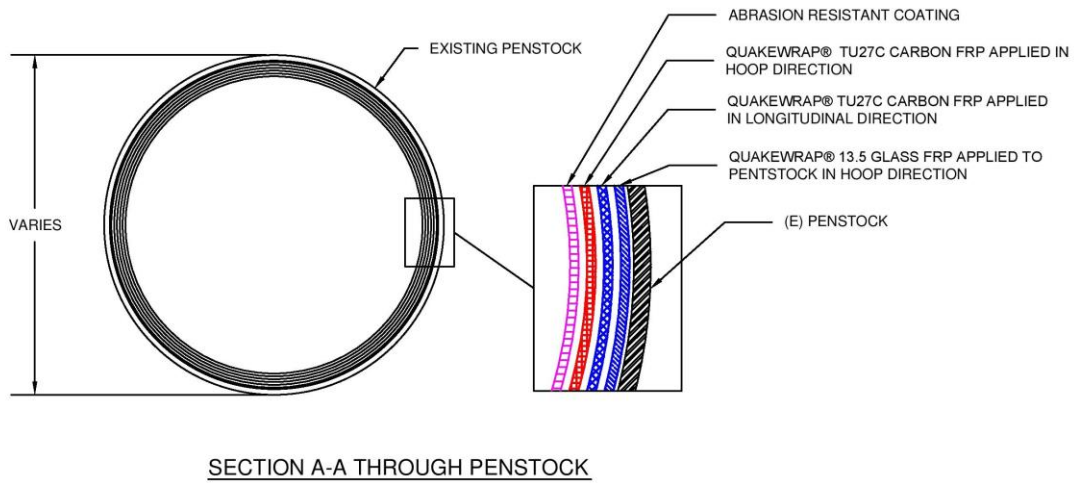
In locations where excessive longitudinal stresses require strengthening of the pipe, layers of the same unidirectional carbon fabric can be applied along the axis of the pipe. In repair of steel structures with CFRP, care must be taken to avoid direct contact between the steel and carbon fibers which acting as dissimilar metals could result in galvanic corrosion. While the epoxy may provide adequate protection, a more conservative approach is to apply a layer of glass fabric as a dielectric barrier to the steel surface. This fabric will serve as a physical barrier to prevent direct contact between the carbon and steel. For this project, a layer of glass fabric was applied to all steel surfaces. Figure 5 shows various layers of reinforcement and coating applied to the penstock. Various layers of FRP and coatings applied to the interior surface of the penstock are shown in Figs. 5 and 6.

Fig. 5. Various layers of FRP and coatings applied to the penstock

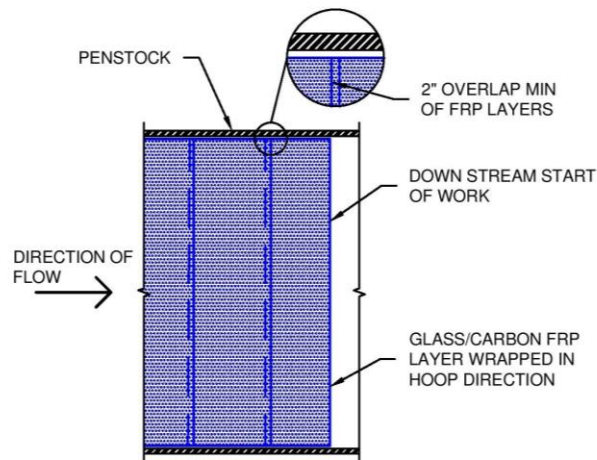
DETAIL 1 - HOOP DIRECTION FRP

The CFR layers in the hoop direction are then applied. These layers are applied in 2-ft wide bands that are 390 inches long. This length is calculated as the circumference of the 120-inch pipe plus an overlap of 12 inches to ensure continuity of the fibers in the hoop direction. The bands are typically applied starting at the most downstream point. The next layer (upstream) will overlap the previous downstream layer by 2 inches. This provides a shingle effect, allowing water to flow over the fabric layers and will prevent the water from getting under the CFRP liner (Detail 1 in Fig. 7). A properly feathered termination point at the downstream of the installation is adequate to ensure against any water penetration (Detail 4 in Fig. 7). For the upstream starting points in each of the 96-inch pipes, a Weko seal was installed. These bands cover the starting point of the CFRP liner and the pressure applied during the installation ensures no water will penetrate behind the liner during service.

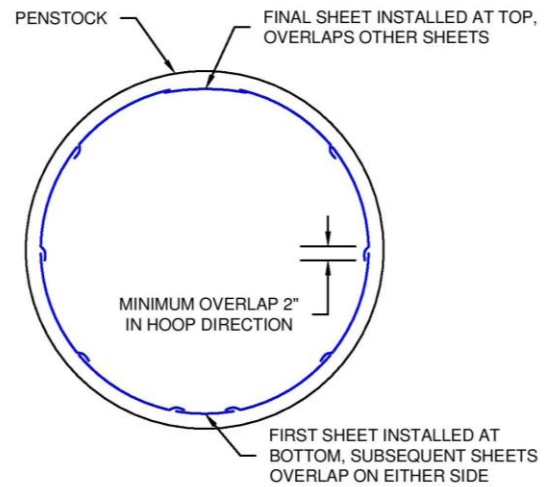
DETAIL 2 - LONGITUDINAL DIRECTION FRP

Details of how individual layers are applied and terminated are shown in Fig. 7. Once the surface of the pipe has been cleaned, the glass fabric that serves as the dielectric barrier is applied first. The CFRP layers in the longitudinal direction are applied next. As shown in Detail 2 in Fig. 7, a small overlap of 2 inches is sufficient for these layers in

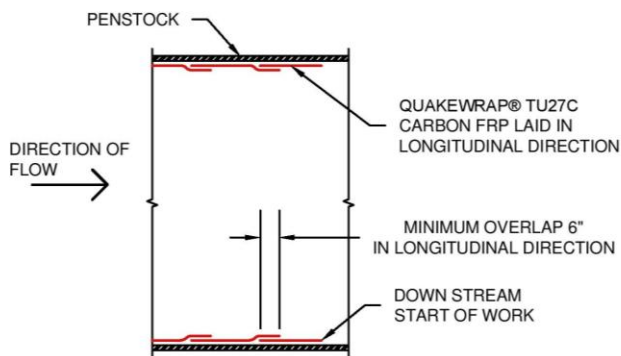
DETAIL 3 - LONGITUDINAL DIRECTION FRP

the hoop direction. Because these layers are serving as longitudinal reinforcement along the length of the pipe, sufficient overlap must be provided in that direction (Detail 3 in Fig. 7).

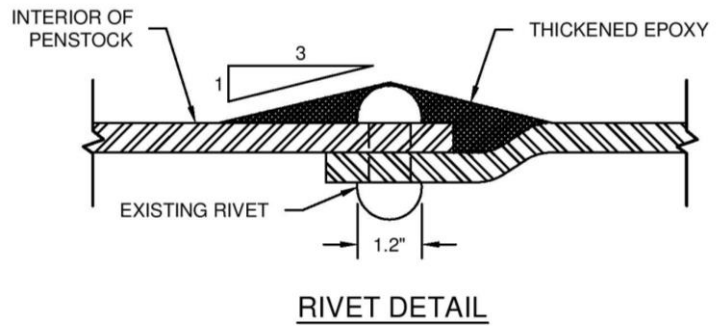
In application of FRP attention must be paid to apply the fabric under a slight tension to avoid any kinks. Otherwise, when subjected to tension, the fabric will want to rid itself of the kinks first before resisting any tension. Similarly, sharp changes in curvature must be avoided. For this reason the areas around the rivets had to be filled with a mix of thickened epoxy. Such epoxy is very thixotropic and can be applied like a viscous paste. Figure 8 shows the detail for repair of riveted areas. The gentle slope produced by application of thickened epoxy ensures proper transfer of force.

Fig. 8. Detail of preparation of the area around rivets prior to the application of CFRP.

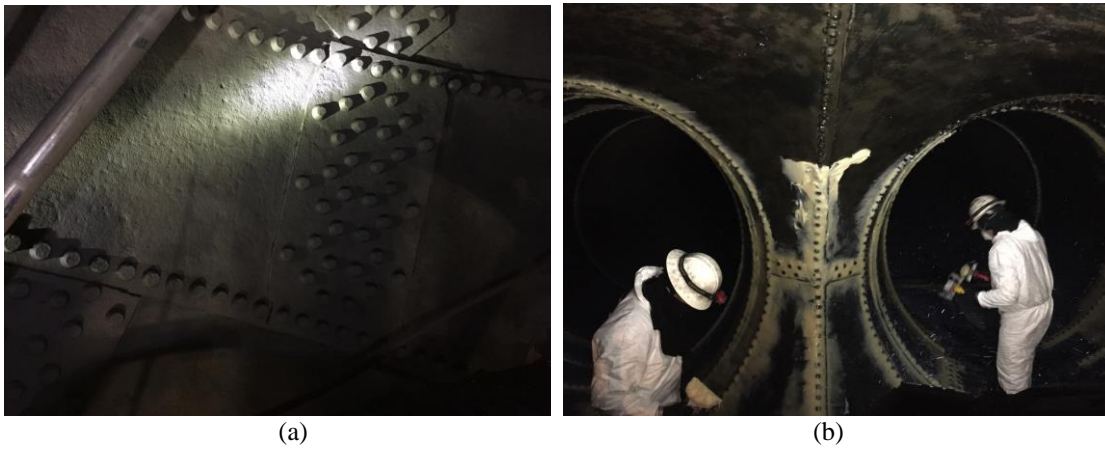
A significant effort was spent to cover the thousands of rivets in the penstock. These rivets protruded from the pipe surface longer than previously assumed. A mix of thickened epoxy was troweled over the rivets to provide a gradual transition to the pipe interior surface. In some cases, chopped glass fibers was also blended with the thickened epoxy prior to

application. Figure 10 shows some of the rivets and the crew applying thickened epoxy in the area. Once the surface was completely prepared, the first layer of glass fabric was saturated with resin and applied to cover the entire interior surface of the penstock.

Fig. 10. (a) close-up of the rivets inside the pipe and (b) coating the rivets with thickened epoxy.

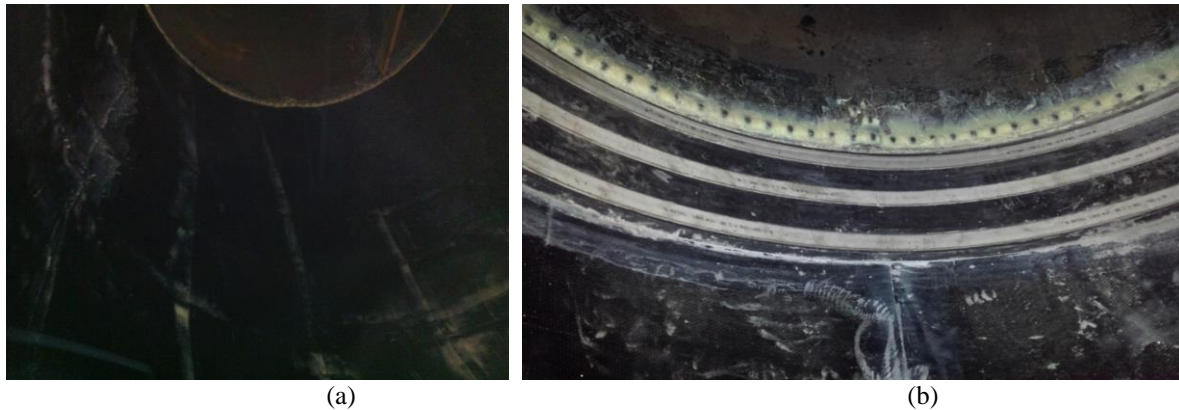
As the layers of fabric are installed, it may be necessary to apply an additional layer of thickened epoxy between the fabric layers. This is necessary especially in overhead applications to prevent the saturated fabric from sliding before the epoxy cures. The overlapping joints and edge of the fabric must also be trimmed and coated with epoxy (Fig. 11a). Once all fabric layers were installed, the leading edge in each of the 96-inch pipes was protected by applying a Weko seal. As discussed earlier, this seal presses the fabric firmly against the host pipe, eliminating the possibility of water reaching behind the CFRP liner (Fig. 11b).

Fig. 11. (a) Repaired penstock prior to application of topcoat and (b) at termination point showing Weko Seal
