# **FRP REHABILITATION OF PIPELINES WITH MINIMUM DOWNTIME: CIVIL ENGINEERS ARE STRETCHING THE LIMITS OF WHAT IS POSSIBLE**

Mo Ehsani, Ph.D., P.E., S.E. and Carlos Peña, M.S., P.E.

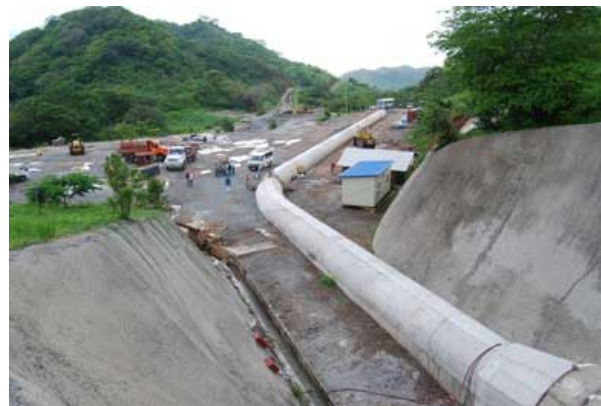
Figure 1: Above ground segment of the “El Encanto” pipeline

The low-pressure pipeline at the “El Encanto” power plant (Fig. 1) conveys river water from an upstream dam to the turbine complex downstream. The pipeline is built of cast in place reinforced concrete, has an inner diameter of 7 ft, and a total length of 5,742 ft. The water flows by gravity, but because of the elevation difference between the dam and turbine complex, as well as the continuous changes in the vertical and horizontal alignment of the pipeline required to conform to the mountainous topography, the water flow is pressurized.

Although the structural design had properly addressed the strength requirements of the pipeline and accounted for the design pressure and hydrodynamic loads, the pipeline’s serviceability requirements were overlooked. The pipeline exhibited significant longitudinal and transverse cracking during a pressurized test and as a result, as much as 20% of the flow was lost due to leaks.

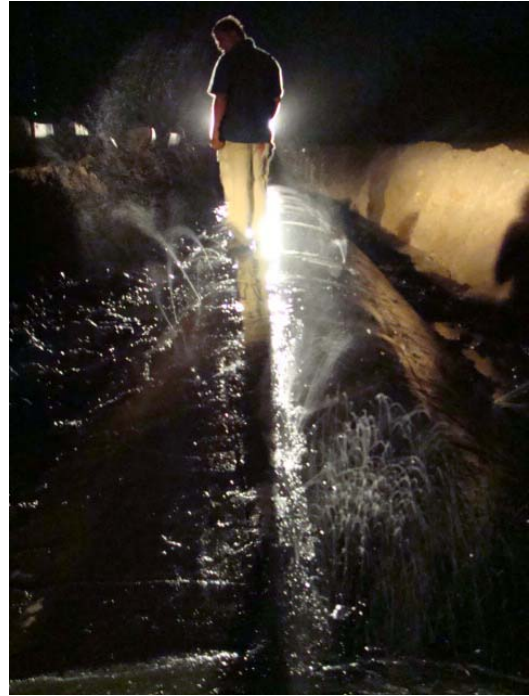
The pipeline was drained and all visible cracks were sealed using typical repair materials available locally. When the pipeline was pressurized for a second time, the repaired cracks leaked again. The leaking at the repaired cracks was most likely due to the increase in the crack width due to the deformations of the pipeline caused by the increase in internal pressure. Given the relative rigidity of most crack sealing materials, full deformation compatibility between the repair material and the surrounding concrete could not be achieved, degrading the integrity of the seal and allowing leaks to reoccur. Figure 2 illustrates typical leaks occurring along the length of the pipeline during tests conducted at maximum operational pressure.

Figure 2: Leaking after conventional crack sealing

An FRP lining consisting of one layer of bidirectional glass fabric was designed to provide a humidity barrier, to offer an effective crack control mechanism, and to supply additional hoop strength to account for future losses of hoop steel due to corrosion. Since in all likelihood the corrosion process at the reinforcing steel had already started due to the two-way humidity paths generated by the existing cracks, the additional hoop strength provided by the FRP effectively increased the useful life of the

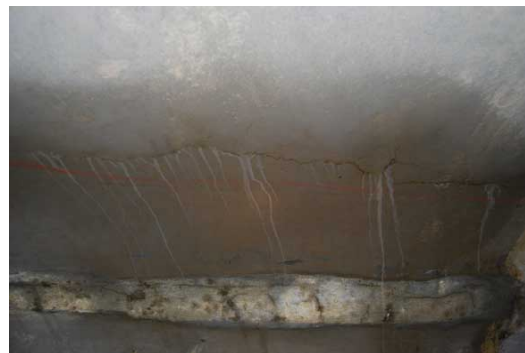
Figure 3: Water seeping into pipeline

Moreover, the cracks generated multiple paths for humidity intrusion that reached the steel reinforcement of the pipeline, allowing for corrosion problems that, if not properly addressed, could compromise the structural integrity of the pipeline in the future. Complicating the problem even further was the combination of mountainous topography and the constant tropical rains. Since most of the pipeline is buried underground, water draining down the mountains keeps the surrounding soil constantly saturated which generates seepage pressures. In fact, with the pipeline empty, seepage water was observed draining through some of the longitudinal cracks (Fig. 3).

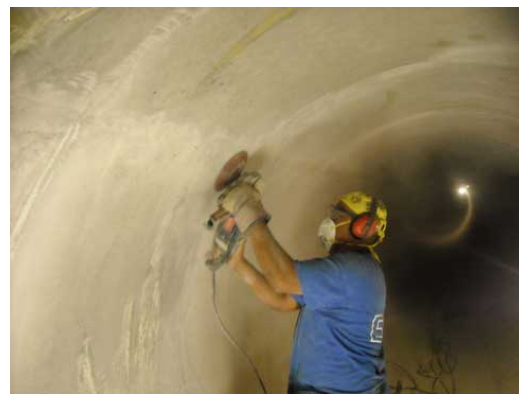
Figure 4: Prep work prior to installation of FRP lining

The application of FRP linings requires a certain amount of preliminary work to the pipe surface in order to maximize contact and bond strength between the substrate and the FRP. Therefore, pressure washing and/or sandblasting, as well as some patching and/or grinding must take place in the areas targeted for lining with FRP. In the case of the El Encanto pipeline, the amount of preliminary work was atypically large, since the cast in place construction process caused significantly more surface irregularities than those associated with the more traditional precast pipes, such as Prestressed Concrete Cylinder Pipe (PCCP). Evidence of cast in place procedures such as construction joints, formwork fins, etc. was visible in the pipeline. The pipeline was pressure washed with 7,000 psi machines to remove any scour, sediment, curing compounds, and any other substance that could hinder the bond between the FRP and the pipe surface. Figure 4 shows grinding of protrusions on the interior surface of the pipeline.

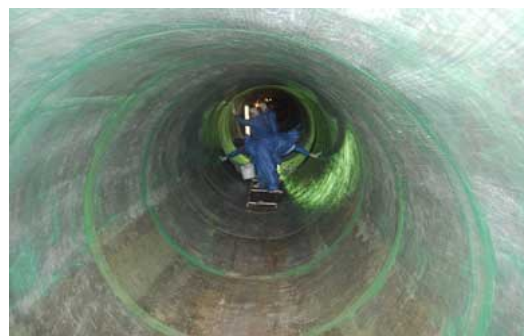
Figure 5: Installation of FRP sheets on the interior surface of the pipeline.

An epoxy paste was applied to the top half of the pipeline; the main purpose of the paste is to prevent peeling due to self weight of the saturated FRP fabric, and to seal the surface to prevent excessive absorption by the dry concrete surface of the epoxy resin from the saturated FRP fabric. Figure 5 shows the installation of the first roll of FRP lining material at one of the installation stations. The access point is clearly visible on the lower left portion of the figure. No epoxy paste was used in the lower half of the pipe. Since gravity forces in this area tend to hold the FRP fabric in place, only a seal coat of epoxy resin was used to prevent excessive absorption by the dry concrete surface of epoxy resin from the saturated fabric. The edges of the 50-inch wide bands of fabric were adequately overlapped in the hoop and longitudinal directions to achieve full continuity of the FRP. The edges of the overlaps were feathered with epoxy paste and/or epoxy resin to secure in place the overlaps in the lining.

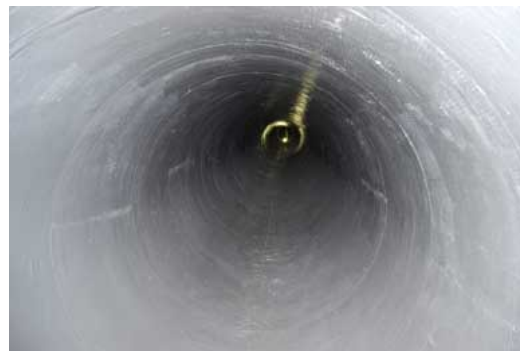
Figure 6: Completed segment of pipeline prior to testing.

The FRP lining installation was completed on July 8<sup>th</sup>, 2009, and pressurized test runs were successfully completed on July 15<sup>th</sup>. Figure 6 shows a completed lining installation prior to testing.
