Repair of Riveted Steel Penstock in Mormon Flat Dam with Carbon FRP

M. Ehsani¹, C. Hurley², and J. Ahumada³

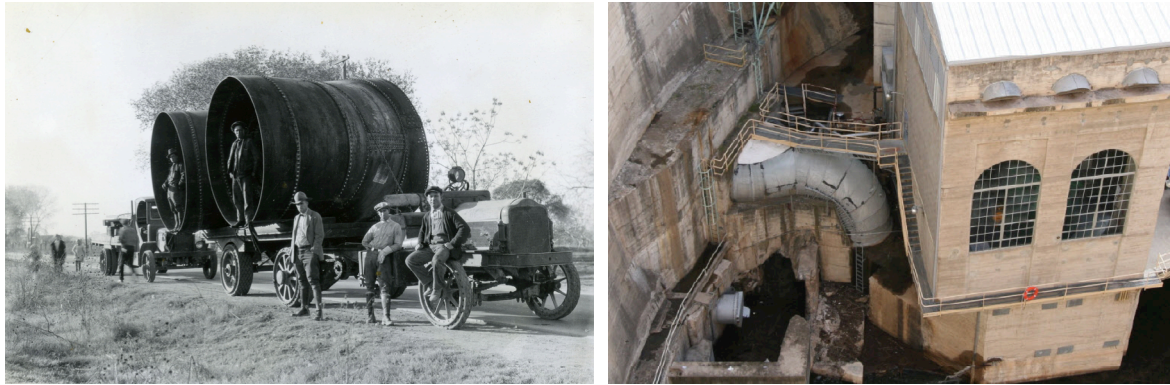
The two 96-inch (2440 mm) diameter riveted steel penstocks were assembled off site and shipped to the job site Fig. 1(a). As shown in Fig. 1(b), these two pipes deliver the water from the dam to a single 120-inch (3048 mm) diameter riveted pipe through a complex geometry. At the Y-connection, the 120-inch (3048 mm) pipe drops in elevation by 20 ft (6.1 m) before turning into a 90-degree elbow. This complicated geometry not only made the original construction difficult, it would also limit the options available for repair of the penstock as mentioned later in the paper.

Fig. 1. The riveted penstock: (a) being transported to the dam c. 1925 and (b) in service.

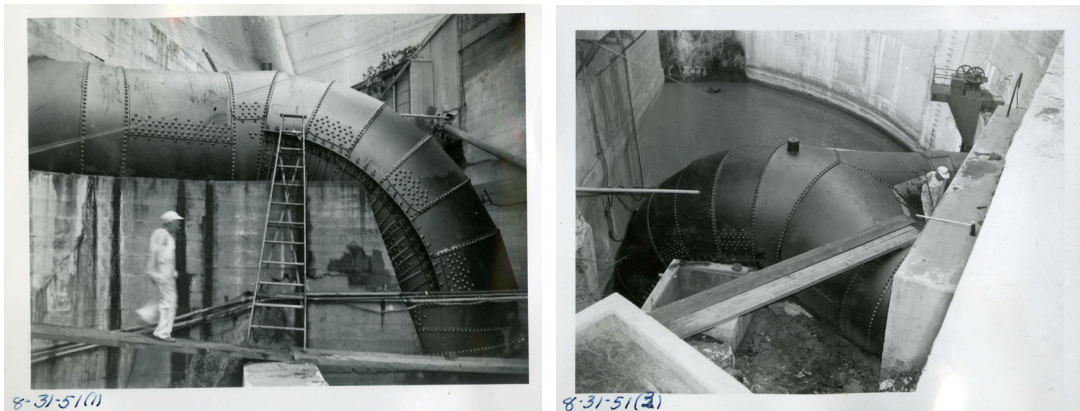
The penstock exterior has always been well maintained with appropriate coatings (Fig. 2). The interior of the penstock is lined with a coal tar coating for protection.

Fig. 2. Periodic inspection and maintenance of the exterior of the penstock – circa 1951.

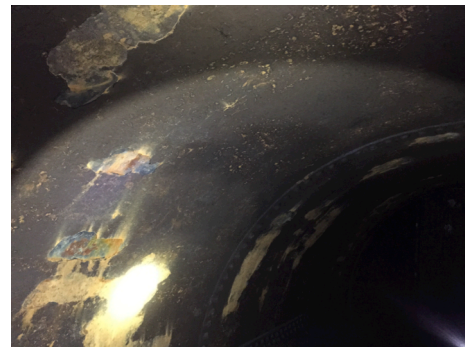
The overall condition of the interior coating was unknown and routine inspections several years ago by SRP raised concerns of possible thinning of the penstock material. More recent inspection showed that the coating had come off in certain points (Fig. 3) and this had accelerated the corrosion rate. A consultant was retained to provide a structural evaluation and recommendations for the penstock. Using ultrasonic testing, the pipe thickness was obtained and a report was prepared indicating that there was material wall thinning percentage of close to 50% of the original thickness in some areas. Their analysis also showed that many of the riveted sections in the exposed

Fig. 3. Damaged tar coating and internal corrosion of pipe

portion of the penstock did not meet the acceptance criteria of ASCE Manuals and Reports on Engineering Practice No 79, Steel Penstocks.

Surface preparation required a near-white SSPC-SP10/NACE10 condition. The interior surface of the penstock was coated with coal tar for corrosion protection. This coating was as much as 2 inches thick in many locations. There were some areas where the coating was damaged (Fig. 3). Most of the coating was removed by mechanical chipping. This was followed by blasting using a special media to obtain a near white surface that would be acceptable for installation of the FRP liner.

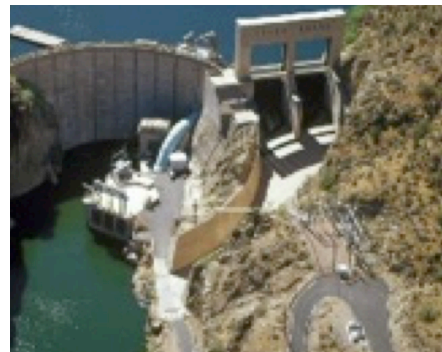
Such design-build contracts are ideal when the project has to be completed in a short time frame and significantly reduces delays due to potential changes in the project. A pre-bid conference was scheduled to ensure that all bidders had a good understanding of the site access restrictions that included being in an area 45 minutes from town with no cellular access. Figure 4 shows the narrow and winding access road along a steep canyon to the dam and the small parking/staging area at the end of the road.

Fig. 4. Limited access to the dam through a winding road and a small parking area.

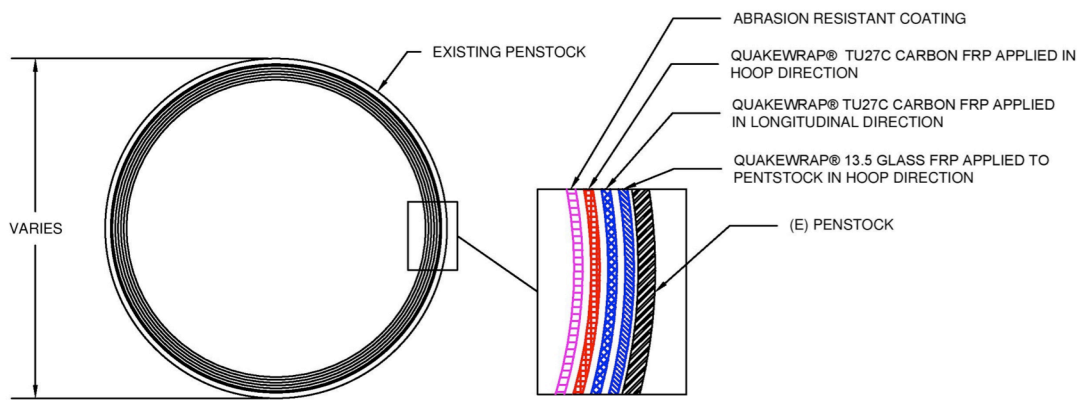
SECTION A-A THROUGH PENSTOCK

Fig. 5. Various layers of FRP and coatings applied to the penstock

contact between the steel and carbon fibers which acting as dissimilar metals could result in galvanic corrosion. While the epoxy may provide adequate protection, a more conservative approach is to apply a layer of glass fabric as a dielectric barrier to the steel surface. This fabric will serve as a physical barrier to prevent direct contact between the carbon and steel. For this project, a layer of glass fabric was applied to all steel surfaces. Figure 5 shows various layers of reinforcement and coating applied to the penstock.

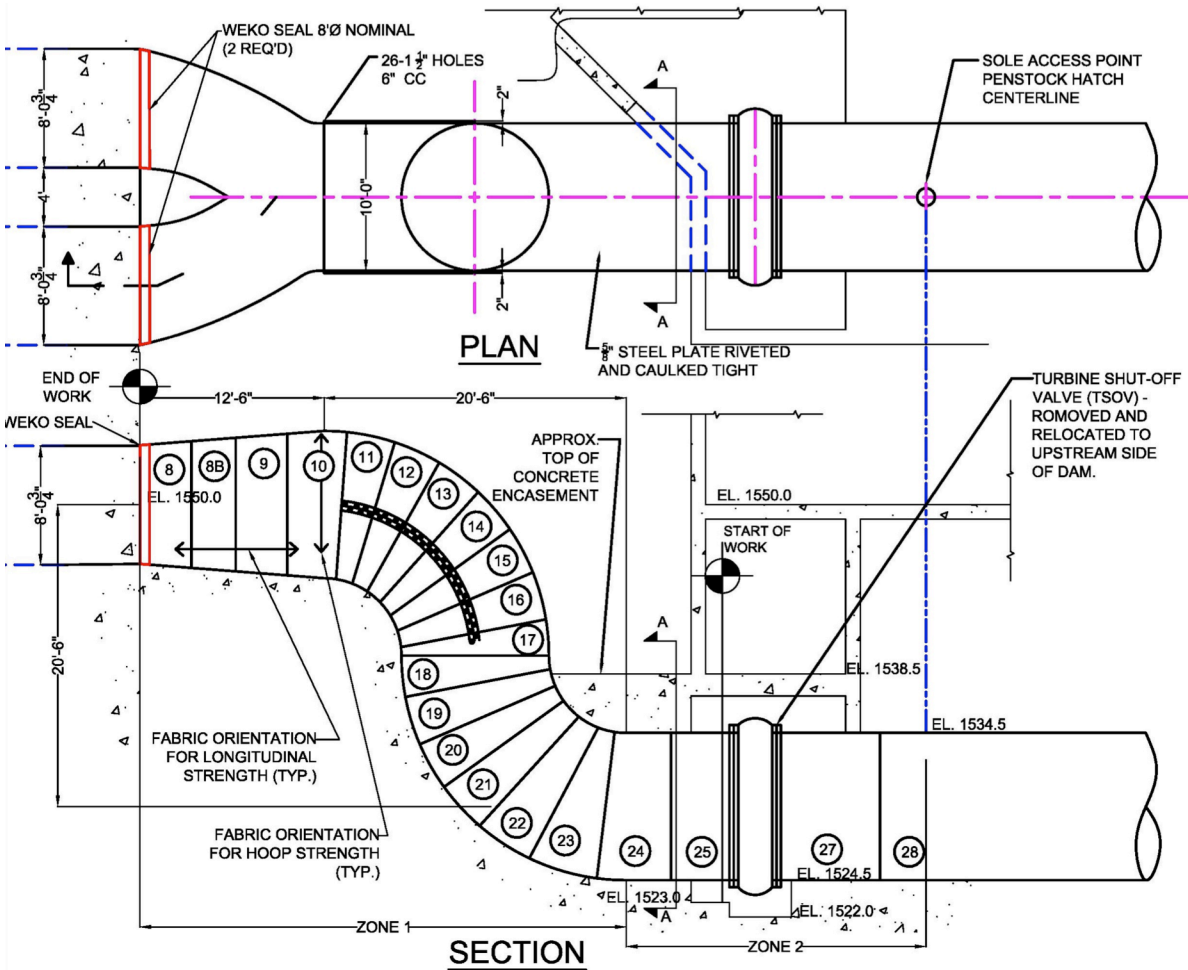
Fig. 6. Overall repair area

Details of how individual layers are applied and terminated are shown in Figs. 6 and 7. Once the surface of the pipe has been cleaned, the glass fabric that serves as the dielectric barrier is applied first. The CFRP layers in the longitudinal direction are applied next. As shown in Detail 2 in Fig. 7, a small overlap of 2 inches (50 mm) is sufficient for these layers in the hoop direction. Because these layers are serving as longitudinal reinforcement along the length of the pipe, sufficient overlap must be provided in that direction (Detail 3 in Fig. 7).

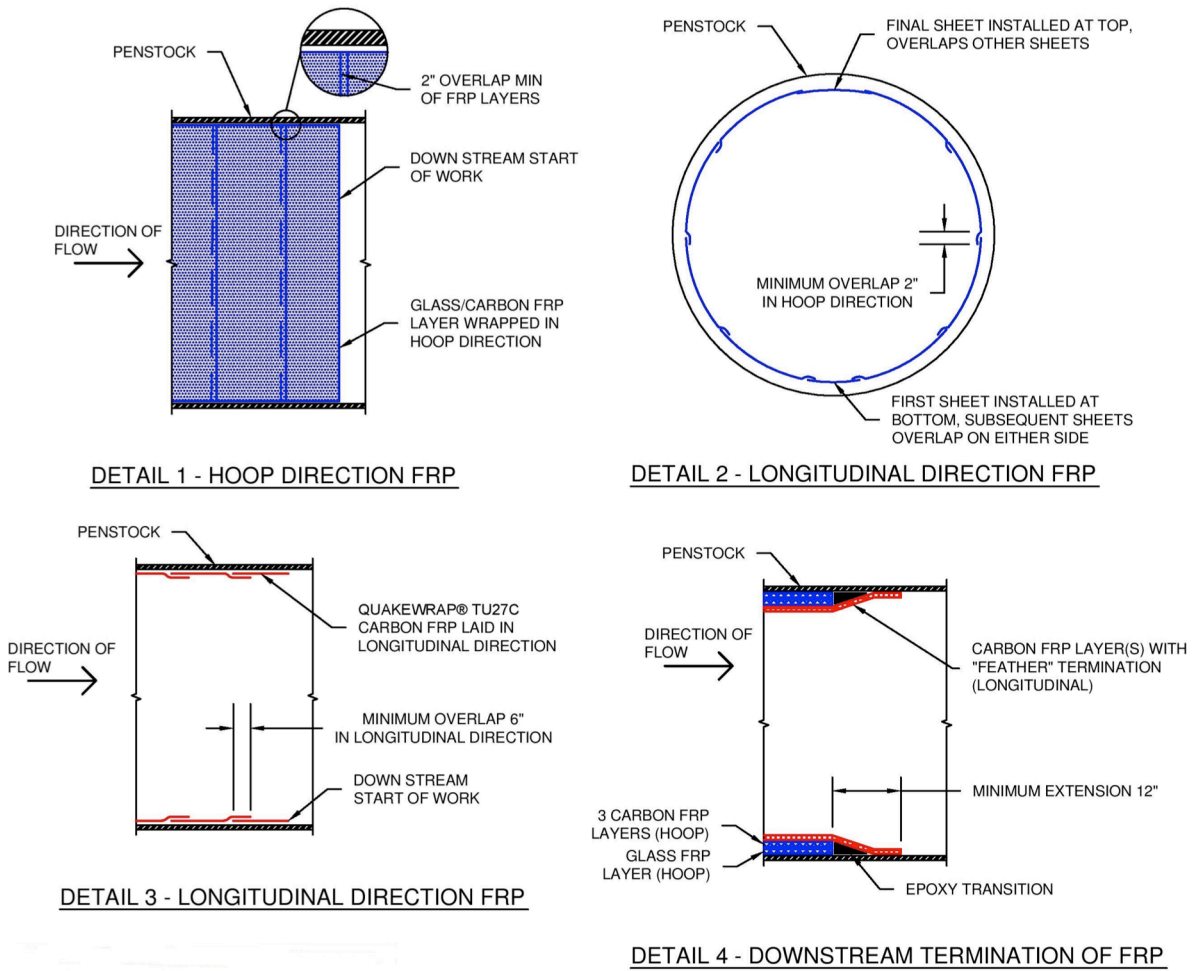
Fig. 7. Various details of the CFRP liner

The CFRP layers were applied in the longitudinal and hoop directions according to the details shown in Fig. 7. The saturation of the fabric utilized a saturating machine and an epoxy metering and mixing pump. This ensured uniform production of the materials in the field and higher quality of the installation. The complex geometry and the large size of this penstock shown in Fig. 10b clearly demonstrates the challenging nature of the repair and why the use of CFRP liners that can accommodate such geometries is an ideal solution for this project. The site engineer representing the materials manufacturer and the design team recorded all batch numbers for fabric, resins and their location of installation.

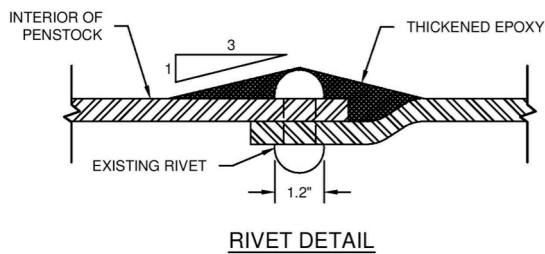
Fig. 8. Preparation of the area around rivets prior to the application of CFRP.

In application of FRP attention must be paid to apply the fabric under a slight tension to avoid any kinks. Otherwise, when subjected to tension, the fabric will want to rid itself of the kinks first before resisting any tension. Similarly, sharp changes in curvature must be avoided. For this reason the areas around the rivets had to be filled with a mix of thickened epoxy. Such epoxy is very thixotropic and can be applied like a viscous paste. Figure 8 shows the detail for repair of riveted areas. The gentle slope produced by application of thickened epoxy ensures proper transfer of force.

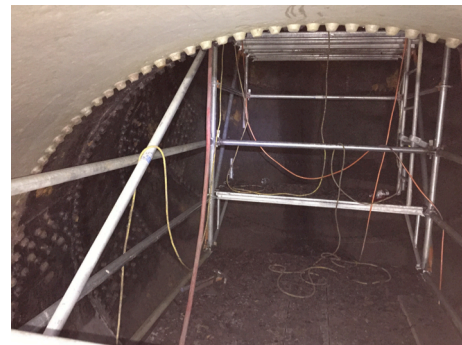
Fig. 9. Scaffolding set up inside the penstock.

To ensure proper ventilation, air quality was continuously monitored by a technician positioned at the entry to the pipe using a 5-gas meter. In addition, the crew was equipped with air-monitoring devices that they would carry inside the pipe. Ring scaffolding was used so that individual pieces could be lowered into the penstock and assembled into a custom unit. The penstock itself had significant change in elevation. Scaffolding was set up in the lower pipe that would reach the entire circumference of the penstock by hand (Fig. 9).

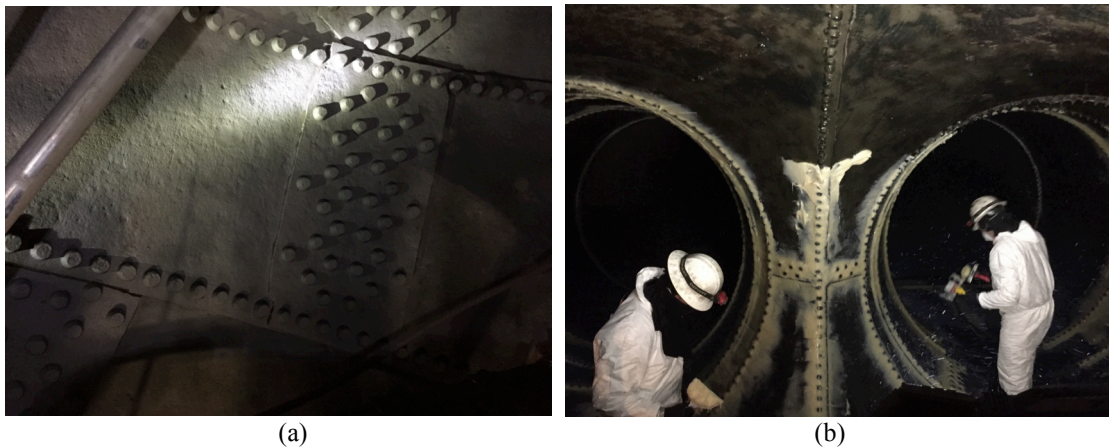
Fig. 10. (a) close-up of the rivets inside the pipe and (b) coating the rivets with

A significant effort was spent to cover the thousands of rivets in the penstock. These rivets protruded from the pipe surface longer than previously assumed. A mix of thickened epoxy was troweled over the rivets to provide a gradual transition to the pipe interior surface. In some cases, chopped glass fibers was also blended with the thickened epoxy prior to application. Figure 10 shows some of the rivets and the crew applying thickened epoxy in the area. Once the surface was completely prepared, the first layer of glass fabric was saturated with resin and applied to the cover the entire interior surface of the penstock.

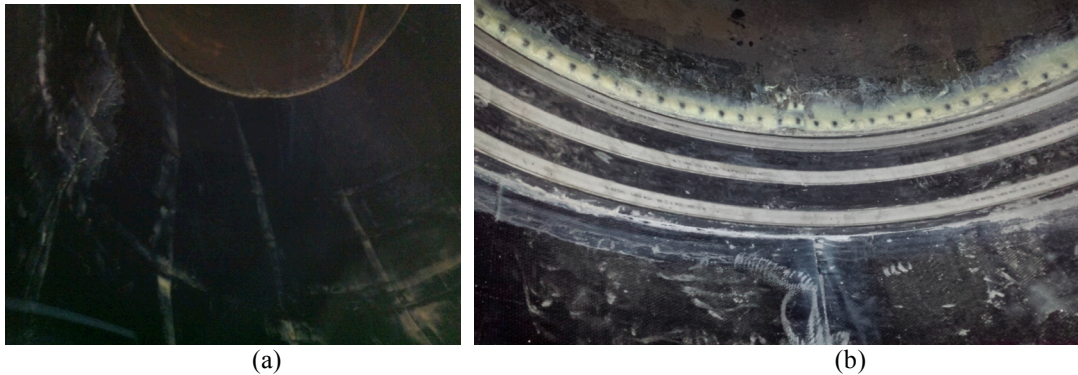
Fig. 11. (a) Repaired penstock prior to application of topcoat and (b) at termination point showing Weko Seal

As the layers of fabric are installed, it may be necessary to apply an additional layer of thickened epoxy between the fabric layers. This is necessary especially in overhead applications to prevent the saturated fabric from sliding before the epoxy cures. The overlapping joints and edge of the fabric must also be trimmed and coated

with epoxy (Fig. 11a). Once all fabric layers were installed, the leading edge in each of the 96-inch pipes was protected by applying a Weko seal. As discussed earlier, this seal presses the fabric firmly against the host pipe, eliminating the possibility of water reaching behind the CFRP liner (Fig. 11b).
