Nashville, TN  
March 11-15, 2012

Paper E-1-01

## Winter Wonderland Does Wonders to CIPP Renewal of a High Pressure Gas Main in NJ

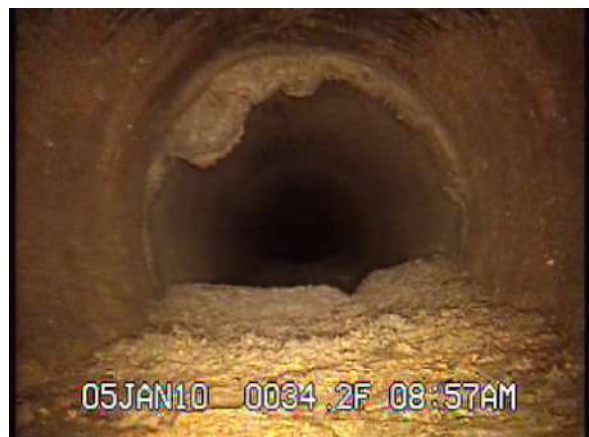
Figure 15. Heavily debris-laden pipe ID.

The original schedule called for this main to be out of service for 7 days. Due to many unforeseen scheduling problems combined with the holiday/vacation season, the pipeline was not abandoned until early January, 2011. The first step was for PPM to CCTV the abandoned segment of the pipe. As it turned out, the location of the gas main was approximately one mile from an old gas manufacturing plant (GMP), and because of the pipeline's close proximity to this plant an extremely heavy build-up of gas residue, including heavy tars, resins, oxides and oils along with heavy deposits of debris was discovered. The internal debris was so heavy and thick that an 8-inch diameter foam pig was unable to negotiate through the 16-inch diameter CI pipe (Figure 15) to enable a tag line to be installed for starting the cleaning process.

Before any work could be performed, a tag line had to be installed which could be used to pull-through a heavier cable for pulling-through the sand blasting equipment to begin cleaning the interior of the pipe. After many unsuccessful attempts trying to get the tag line through using standard procedures, techniques and equipment, a parachute-type concept was developed on site to successfully get the tag line through from one end of the pipe to the opposite end.

Conventional internal sandblasting tooling was tried but was ineffective in adequately removing the heavy debris. The sandblasting tool head was modified on-site to deflect the majority of the grit towards the bottom of the main in an effort to remove the excessive debris. This equipment modification included the successful adaptation of using a camera to view the sandblasting operation simultaneously - something that had never been done before. While being somewhat successful, the modified tooling still provided insufficient cleaning power to open-up the main to its full 16-inch diameter.

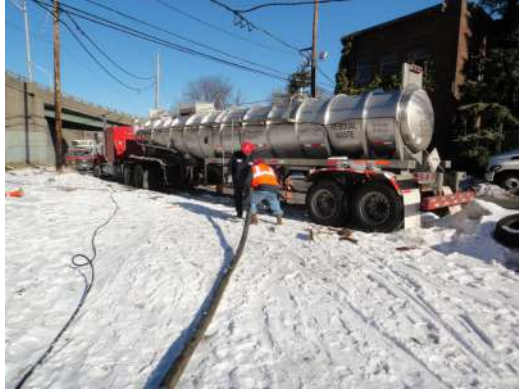
Figure 17. Vacuum tanker collection truck.

Additional cleaning was required and high pressure water jet blasting equipment was the next logical step. (Figure 16) This equipment uses water at 15,000 psig and is capable of cleaning-out the heavy debris. However, this now posed an additional set of unique problems involving equipment freeze-ups, working in the dead of winter, water supply/removal/disposal, hazardous material collection trucks, and heaters with associated project time delays. Before water jetting could be implemented, PSE&G's Environmental Department needed to be involved to oversee and manage the collection of all the waste-water material to ensure compliance with applicable environmental regulations using the vacuum collection tanker (Figure 17).

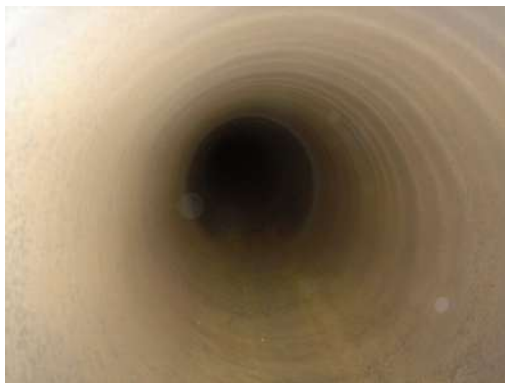
Figure 18. Pipeline ID fully cleaned.

The water jetting was followed by removal of the water using foam pigs and then an extensive period of time was spent on drying the inside of the pipe using hot air injected into the pipeline. Once dry, the normal sandblasting operation was started and successfully brought the ID of the pipe down to a bright white metal finish (Figure 18) in preparation for cutting the drip pot standpipe internally, installing the FRP laminate and then lining through the entire 700-foot segment of pipe.

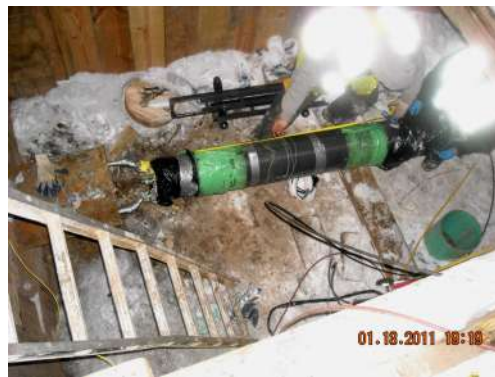
Figure 19. Inflatable pig/laminate being inserted.

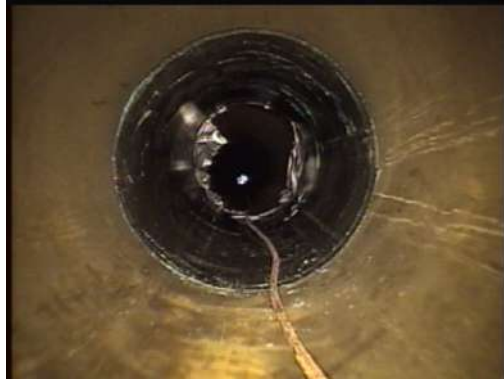
Figure 20. Final drip pot bridge laminate assembly.

The  $\frac{3}{4}$ -inch diameter steel drip pot standpipe was successfully cut-off in two cuts as planned using the specially designed and built robotics platform. This cleared the way for installing the FRP laminate internal sleeve/bridge as the final step before lining the entire abandoned segment of pipe. With the help of QuakeWraps's technicians, the FRP laminate installation went smoothly. Figure 19 depicts the inflatable pig with the FRP laminate sleeve installed onto it being ready to be pulled out to the drip pot. The adhesives used for the FRP laminate normally cure over one night, but due to the extremely bitter cold weather it took three nights. After the third night, the inflatable pig was deflated and removed with the FRP laminate bridge in final place spanning the drip pot gap (Figure 20).

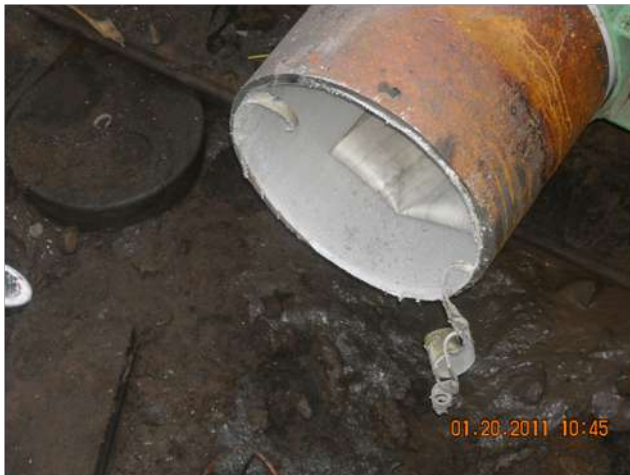
Figure 21. Excess liner being trimmed at pipe-ends.

The pipeline ends were trimmed of liner for facilitating connections to the existing piping (Figure 21) and final internal CCTV inspection was performed as a part of the acceptance criteria. This inspection confirmed a perfect lining job from end-to-end of the pipeline right through the FRP laminate bridge (Figure 22) creating a gas tight condition and resolving the nagging leaks in the area.

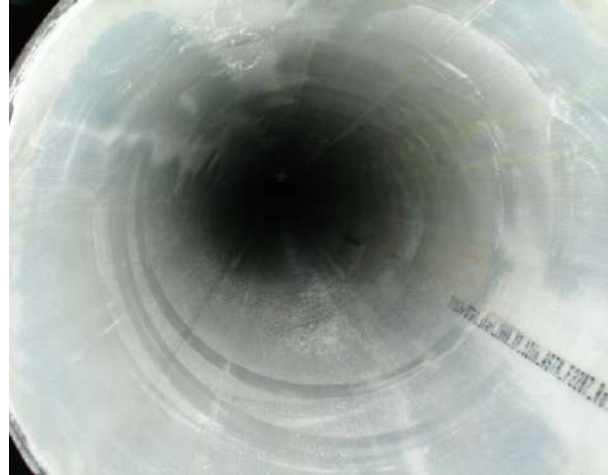
Figure 22. Completed liner installation with the FRP laminate
