North American Society for Trenchless Technology (NASTT)
NASTT's 2018 No-Dig Show

MM-T1-04

Corrugated City of Steam – Emergency Repair of the Drama Tunnel

Mo Ehsani, Professor Emeritus of Civil Eng., U. of Arizona, and President, QuakeWrap, Inc.,
Tucson, AZ USA

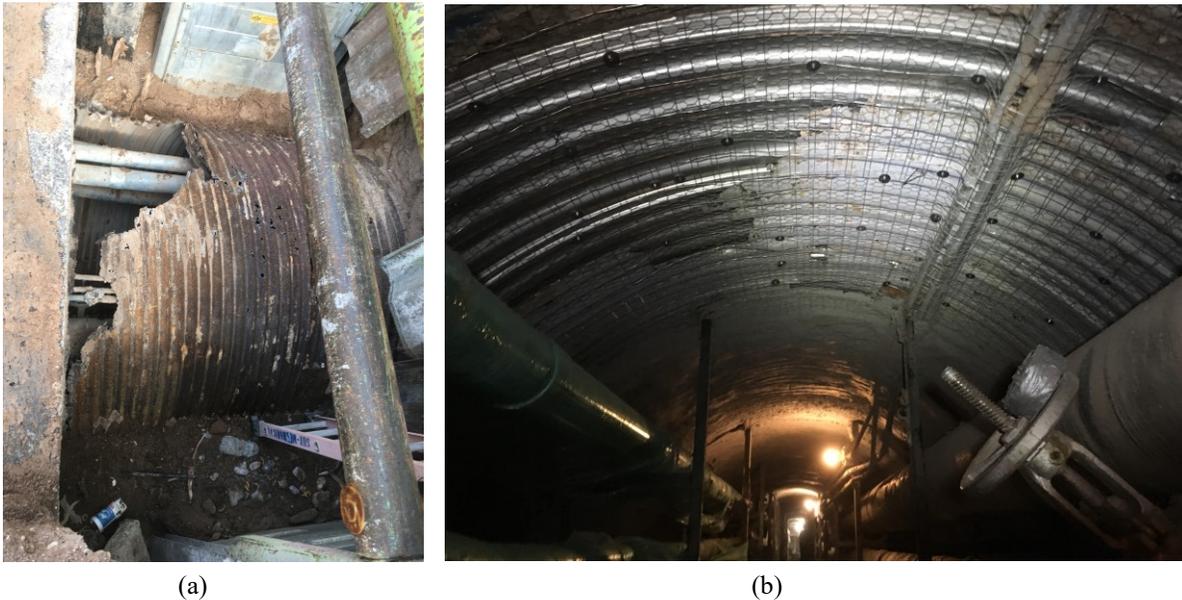
The utility tunnel in this project was constructed of corrugated metal pipe (CMP). It has a diameter of 96 inches and houses several pipes, including one that conveys steam. Consequently, the temperature inside the pipe is above 115 °F. About a month before the beginning of the Fall 2017 semester, a section of the deteriorated tunnel failed. The soil and concrete sidewalk above the pipes partially caved into the pipe. The University immediately contracted with Sun Mechanical Contracting, Inc, an Arizona-based full-service mechanical contracting and construction firm with offices in Tucson and Phoenix, to perform the repairs. As the first step, Sun Mechanical removed the soil from the top of the tunnel to eliminate the gravity loads acting on the pipe. Temporary shoring was also provided by Sun to prevent collapse of the surrounding soil (Fig. 3a). The figure also shows how badly the crown portion of the CMP had corroded.

Fig. 3. (a): Removal of the soil above the failed tunnel and shoring of the trench; and (b): Placement of new corrugated segment at the crown and the steel reinforcing wire mesh.

Figure 3(b) shows the tunnel with the new segment of corrugated metal pipe placed at the crown region and bolted to the old pipe. A steel wire mesh was attached to the entire surface of the tunnel (Fig. 3b). The design included spraying a 3-inch thick layer of gunite to the entire surface of the 162-ft long tunnel. The design details are shown in Fig. 4.

As stated earlier, to prevent full collapse of the tunnel, the general contractor installed a partial piece of 96-inch diameter corrugated steel pipe on the crown section of the old tunnel and bolted the old and the new section together. Considering the 115-degree temperature in the tunnel, a 35-ton air-conditioning unit was used to provide cool fresh air in the tunnel for a workable environment.

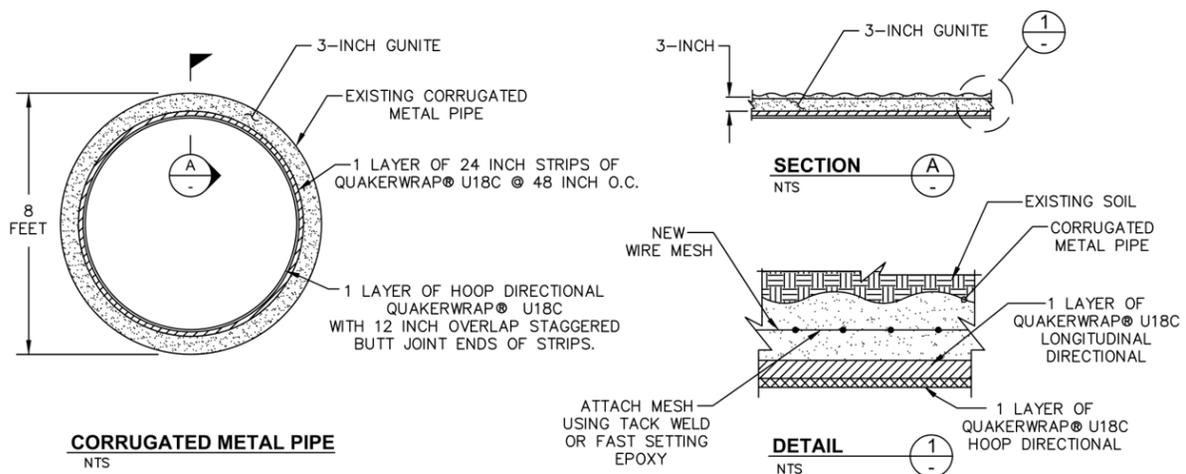
Fig. 4. Design of the retrofit system for the corrugated metal pipe tunnel.

Carbon FRP fabric was applied in two layers on top of the gunite. The first layer consisted of 24-inch wide bands of a carbon fabric at a centre to centre spacing of 48 inches, applied in the longitudinal direction. This fabric has an effective tensile strength of 3,895 pounds per inch; so, each 24-inch band provides a nominal tensile force of $3,895 \text{ lb/in} \times 24'' = 93,480$ pounds. Since the bands were placed at 48-inch on centre, this fabric provided an average tensile resistance of $93,480 \text{ lbs}/48'' = 1,947$ pounds per inch along the circumference of the tunnel. This is almost equivalent to providing No. 5 Grade 40 steel bars at a spacing of $6 \frac{1}{2}$ inches distributed around the circumference of the tunnel.

The second layer consisted of the same 24-inch wide carbon fabric applied in the hoop direction. Each band was cut to a length of 26.2 feet to cover the full circumference of the tunnel with a 12-inch overlap at the end for development length. Adjacent bands would be similarly installed with a 2-inch overlap along the length of the tunnel. With calculations similar to those shown above, it can be demonstrated that this fabric provided a strength of 3,895 pound per inch in the hoop direction. This is equivalent to placing No. 5 Grade 40 steel reinforcement at $3 \frac{1}{4}$ inches on centre in the hoop direction. Thus, the carbon FRP solution provides significant strength to the pipe/tunnel.

As a protective layer, a chemical resistant epoxy coating was applied to the top surface of the finished installation. The details in Fig. 4 show the various layers of this composite design.

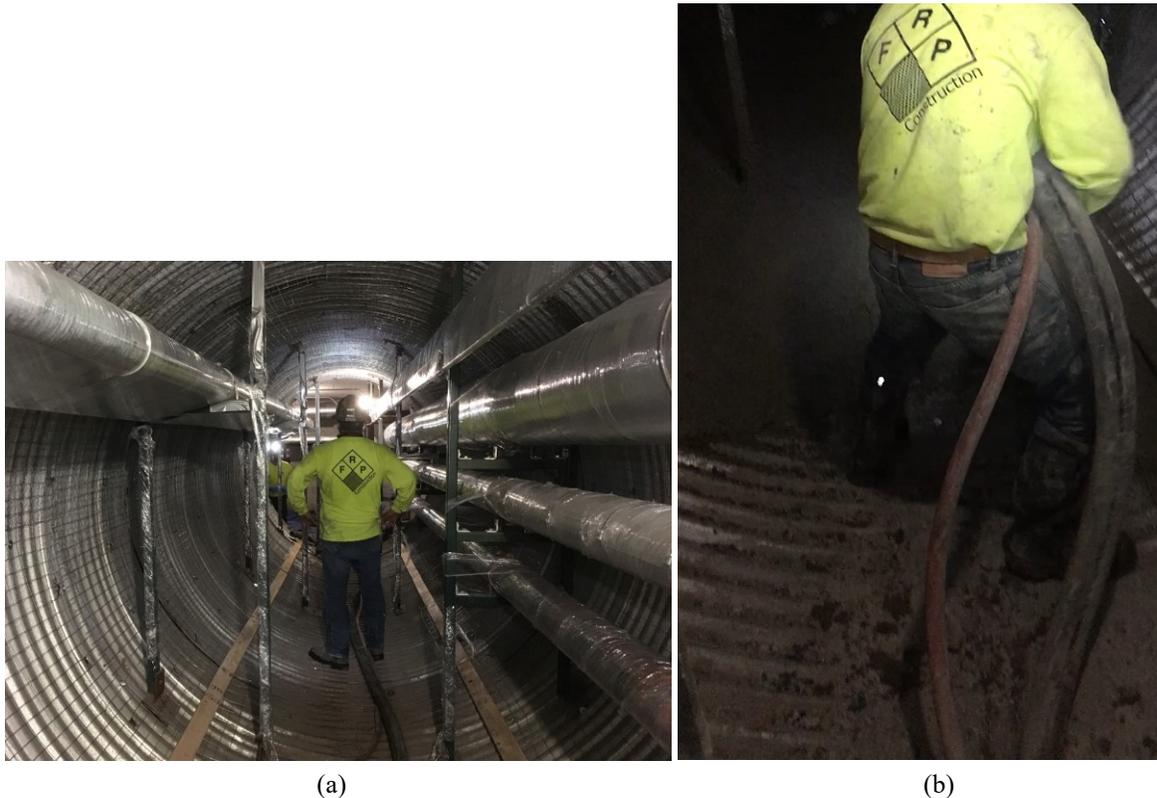
Fig. 5. (a): Attachment of steel wire mesh; and (b) application of gunite.

The first step in the repair consisted of covering all pipes within the tunnel to protect them from dust and resin during the repairs. This was followed by attaching a steel wire mesh to the interior of the tunnel (Fig. 5a). Next, a 3-inch thick layer of gunite was applied to the interior of the tunnel. Although shotcrete is a lower cost alternative, the distance for the mixed materials to be transported in the hoses was too long and would have caused the shotcrete materials to harden while in transit. In contrast, gunite that mixes the dry components and water at the nozzle, makes this operation easier. Figure 5b shows the application of gunite to the tunnel. The surface of the gunite is troweled

and made fairly smooth with a concrete surface profile (CSP) of 3-light abrasive blast, which is ideal for application of FRP.

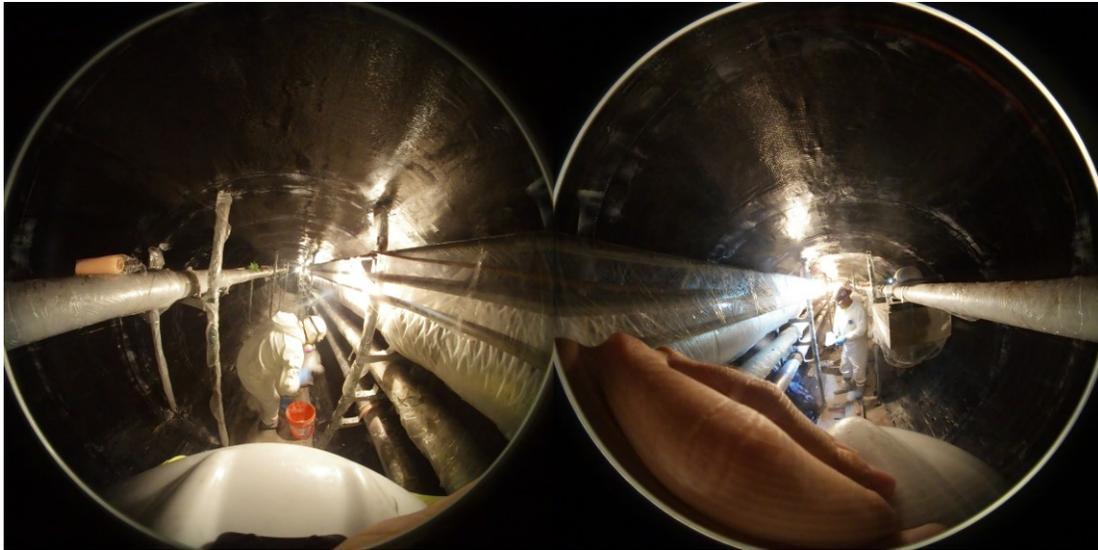
Fig. 6. 360-degree view of the tunnel looking forward and backward during the installation of the FRP.

This was followed by installation of the carbon FRP in the hoop direction. These were cut in 26.2-ft long pieces that would cover the circumference of the 96-inch tunnel plus a 12-inch overlap at the end of each band. Adjacent strips were applied with a 2-inch overlap until the entire length of the tunnel was strengthened with carbon FRP. Figure 6 shows a 360-degree view of the tunnel during the installation of the FRP.

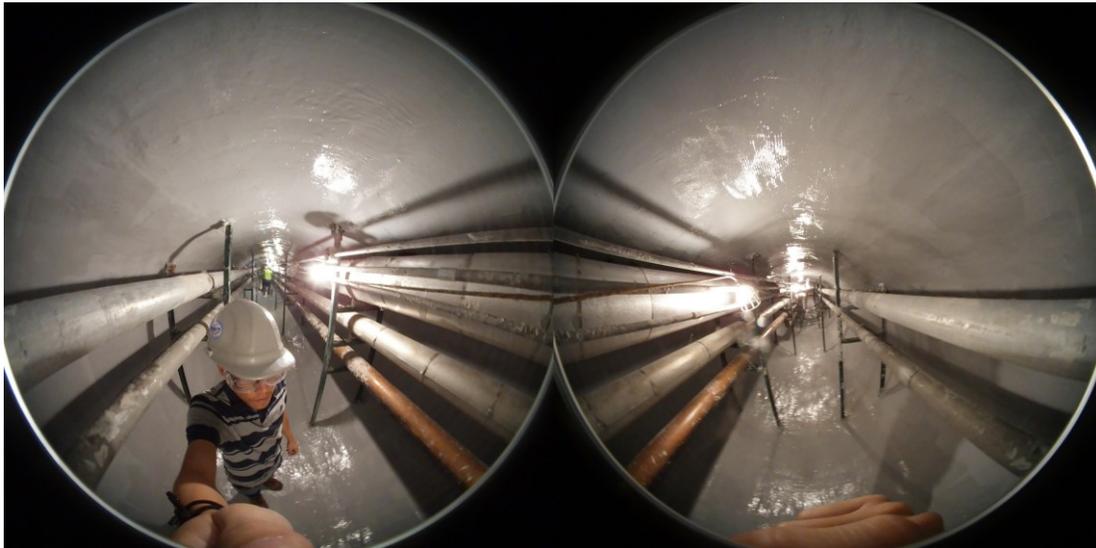
Fig. 7. 360-degree view of the tunnel looking forward and backward during the final inspection after the installation of the FRP and top coating.

To provide further protection for the FRP, and a more aesthetic appearance, a final top coat of a chemical-resistant coating is applied to the surface of the FRP. This coating is grey and as shown in Fig. 7, it provides a nice interior surface for the tunnel.

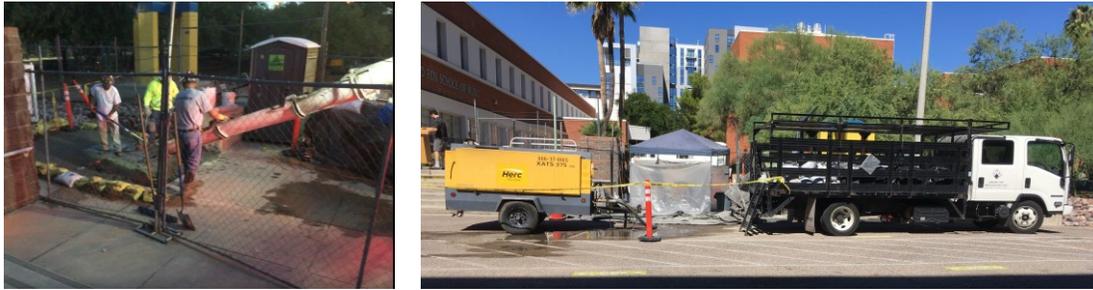
Fig. 8. Placement of concrete to restore the collapsed sidewalk area

Once the tunnel was repaired, the area above the tunnel was filled with soil, compacted and a concrete slab was placed, returning the area to its original configuration (Fig. 8).
