## A New Generation of FRP Laminates for Repair of Pipelines in Gas Industry

Mo Ehsani, PhD, PE, SE, F.ASCE

President, PipeMedic, LLC and Professor Emeritus of Civil Engineering, University of Arizona, 2055 E. 17<sup>th</sup> St., Tucson, AZ 85719; (520) 791-7000

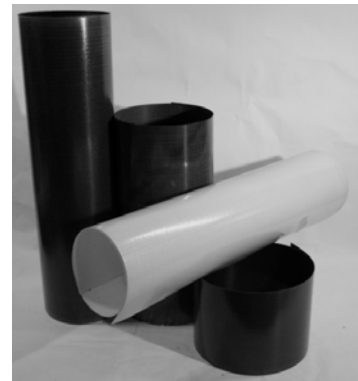
Figure 1. PipeMedic Laminates

The development of PipeMedic™ laminates began in 2008 (Ehsani, 2009; Figure 1). Using a special manufacturing process, these laminates are constructed with one or more layers of carbon or

glass fabric saturated with resin and pressed together to form a very thin solid sheet. The laminates are manufactured in rolls 4-ft wide x 150-ft long that can be easily cut to any size in the field. With a thickness of about 0.01-0.025 inches, the laminates are flexible enough to be coiled for insertion into pipes as small as 4 inches in diameter. The tensile strength of the laminates ranges between 60,000 – 145,000 psi.

The high strength of the laminates in two orthogonal directions allows them to resist both hoop and longitudinal stresses that could be present in certain applications. Furthermore, these laminates incorporate a thin glass veil on both surfaces; this allows the laminate to be in direct contact with steel pipe surfaces without any concern about galvanic corrosion that could result by allowing carbon fabric and steel to come in contact with each other.

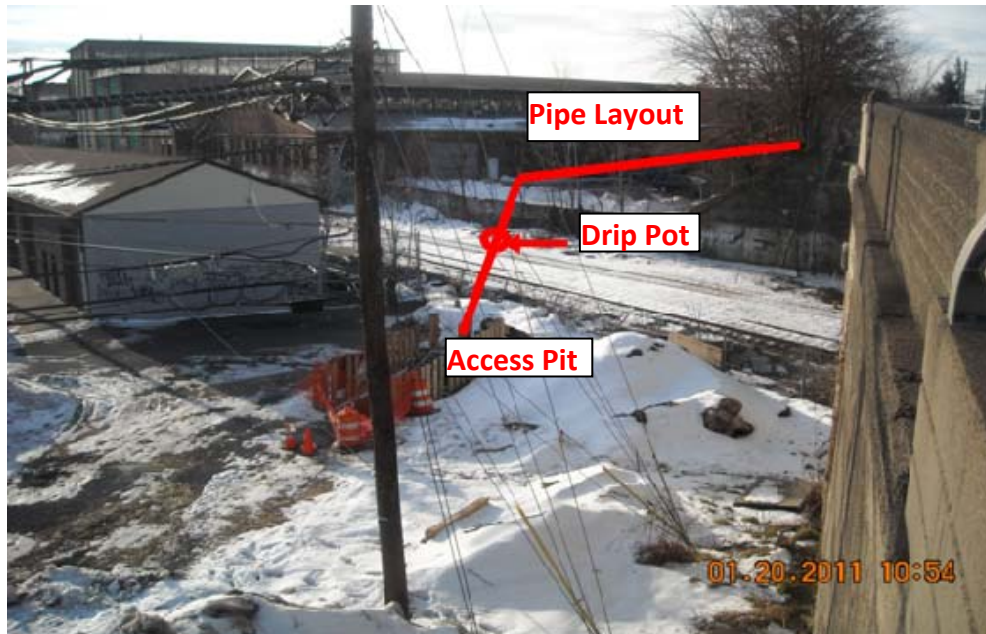
Figure 6. Project site showing the existing pipe layout and drip pot location under the railroad tracks.

The first installation of PipeMedic™ was in a 16-inch pipe in Paterson, NJ. The installation was completed in February 2011 by Progressive Pipeline Management (PPM) with supervision and training for the installation of PipeMedic™ provided by QuakeWrap. The overall length of the pipe to be lined was 700 feet and the drip pot was located directly under the railroad tracks nearly 85 feet away from the access point (Figure 6). Considering the adverse winter weather, the job offered unique challenges that had to be overcome (Carbone et al. 2012).
