Eleventh U.S. National Conference on Earthquake Engineering
Integrating Science, Engineering & Policy
June 25-29, 2018
Los Angeles, California

AN INNOVATIVE SOLUTION FOR SEISMIC RETROFIT OF STEEL CONCENTRIC BRACED FRAMES

M. Ehsani¹, A. Agarwal² and R. Fleischman³

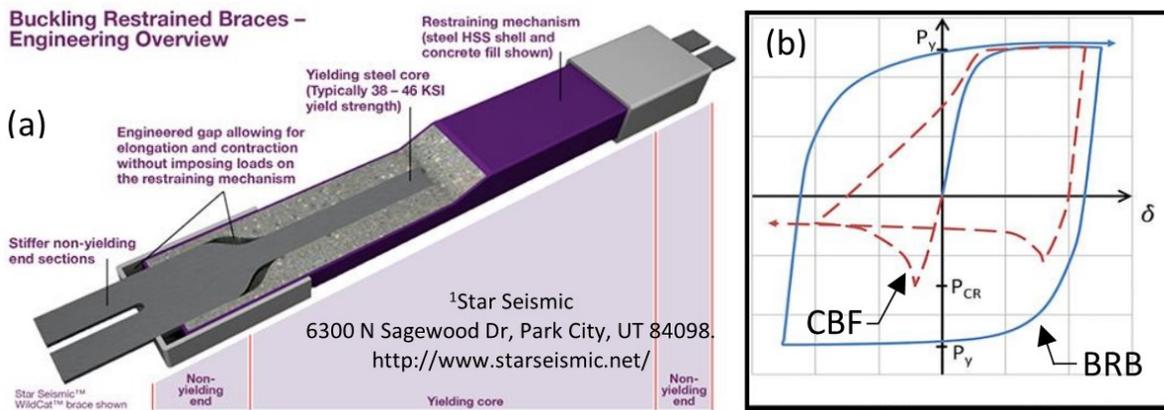
Figure 1. BRB: (a) Schematic; (b) Load Deflection Comparison with CBF [4].

The BRB is a seismic bracing element that responds in ductile fashion to an earthquake. BRBs use an unbonded confining tube around a slender steel bracing core (Fig. 1a), thus allowing the core to yield in tension, but suppressing buckling in compression [4]. The typical BRB is: (1) a single piece yielding steel core with stiffer non-yielding end sections; (2) a restraining mechanism, often a steel tube with filled concrete with an end gap to permit permanent elongation. Under tension, the BRB behaves as a traditional steel brace; however, under compression, the yielding core is prevented from buckling by the restraining element, resulting in ductile, symmetric load behavior with high energy dissipation and compression strength than a CBF (See comparison in Fig. 1b). The BRB has been widely studied and is now commonly used for new construction of special seismic frames. The high-performing BRB is quite expensive (\$25K/unit) [4].

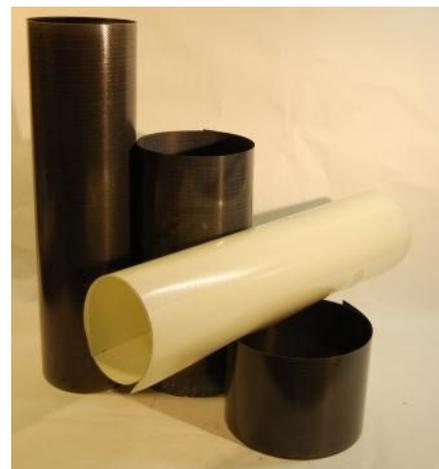
Figure 2. New laminates: carbon (black) and glass (white).

(glass or carbon), the laminates provide a tensile strength ranging from 60 to 155 ksi. Typical thickness of the laminates is 0.025 in., resulting in a flexible laminate that can be bent by hand (Fig. 2).

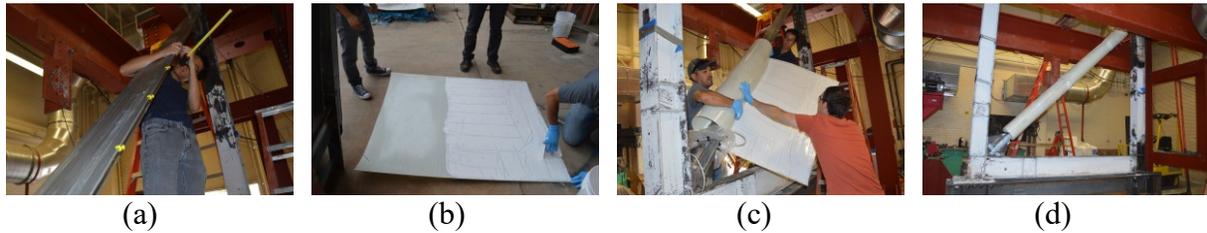
Figure 3. Retrofit for BRB using BraceWrap® includes: (a) applying debonding material, (b) apply epoxy, (c) wrap laminate around the brace to create a tube, and (d) fill the tube with concrete.

Due to space limitation, the retrofit steps are shown using the photos from a specimen that was tested as described in the following section. To ensure proper behavior as a BRB, a debonding agent should be used to prevent composite action between the brace and the concrete. In this case, duct tape was applied to the brace and it was coated with a bond-breaking material. Special plastic spacers were used along the edges of the brace to make sure the laminate does not come in contact with the brace (Fig. 3a). The 4-ft wide laminate is cut in a length equal to twice the perimeter of the tube to be made, plus 8 inches. An epoxy paste is mixed and applied to the laminate except the portion that will be directly facing the brace (Fig. 3b). The laminate is wrapped around the brace and bonded to itself to create a two-ply tube of desired diameter.

Because the epoxy has not cured yet, the size of the tube can be adjusted and temporarily held in the desired size using a few ratchet straps that are wrapped around the tube. The bottom of the tube is sealed, and the tube is filled with concrete. The next laminate is similarly installed,

with an adequate overlap length that is epoxied to the first tube. This process is continued until the entire brace is retrofitted in 4-ft increments.

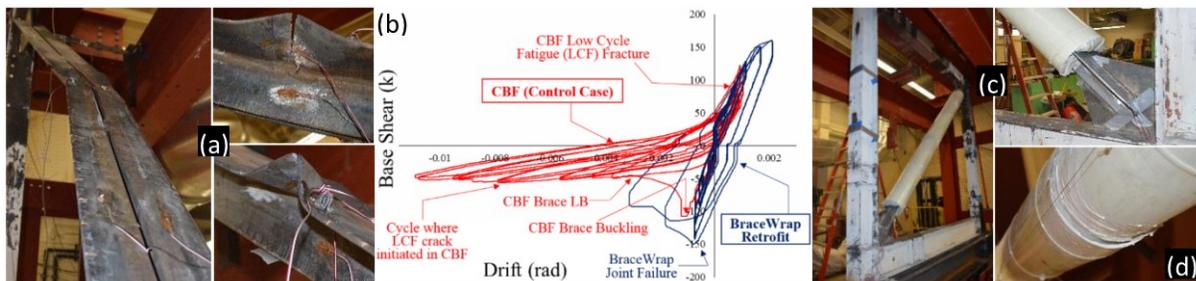
Figure 4. Pilot testing: (a) CBF failure; (b) Response; (c) BraceWrap®; (d) BraceWrap® joint failure

A pilot test for BraceWrap proof of concept performed at the UA Laboratory. The test objective was to directly compare the performance of a CBF w/ and w/out the retrofit. The brace element was a welded double angle LL3½x3½x¼ with effective slenderness $KL/r = 87.9$. The BraceWrap retrofit (See Fig. 4c) used a 60ksi glass laminate formed into an 8¼” cylinder shell, held in place

The unretrofitted brace incurred flexural-torsional buckling, leading to a rapid drop of load, followed by local buckling of the plastic hinge region, and after a few buckling-straightening cycles, a low-cycle fatigue fracture through the entire outstanding flange of the hinge region (Fig. 4a). BraceWrap® successfully increased the buckling load of the brace by over 40%, significantly increased energy dissipation, and suppressed the local buckling and low-cycle fatigue failure of the brace (Fig. 4b). Just this improvement can make the difference between significant damage and modest damage in a CBF structure, or even prevent collapse for a highly vulnerable CBF.

However, lessons learned in the test provided insight into oversights in the installation process for the pilot test that are easily remedied, and should lead to significant further increases in strength and performance. Foremost was the inattention to the location of joints between the laminate sheets. For convenience, the sheets were placed from the bottom of the brace (with grout inserted in stages). As such, one of the joints was located within 2½” of the brace mid-span. This joint failed (Fig. 4d), leading to the loss of load carrying capacity. It is believed that simply centering one of the sheets to straddle the mid-span would be enough to eliminate this failure. However, increasing the minimal laps (12” overlap) and epoxy used in this first trial are also parameters that warrant further investigation. It was clear from the test that the single sheet of laminate itself is strong enough to carry the hoop stresses; however, a second layer of staggered sheets over the joints is always possible at minimum extra cost. Finally, the desire to minimize the cross-section left the minimum grout cover 3/8” at the outstanding flanges. While it is not believed this led to the failure, the 8¼” diameter could easily be increased to provide more cover, and will be a design parameter.
