Fiber Reinforced Polymers

Seismic Retrofit of the McKinley Tower

By Mo Ehsani, Ph.D., P.E., S.E.

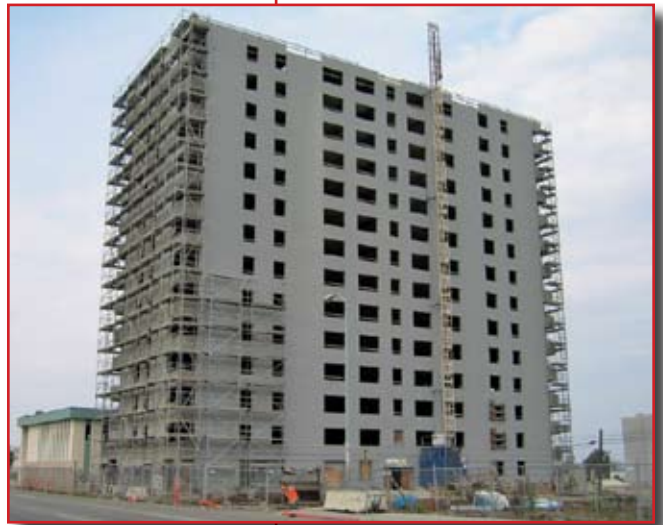
Figure 1: Damaged McKinley Tower sat vacant for more than two decades.

After the earthquake, the building was vacated and put up for auction. In 1965 some repair work was done consisting of exterior crack patching, replacement of damaged reinforcement of ornamental spandrel beams, removal of loose material, and fixing spalled areas in stairwell and elevator core (Figure 1).

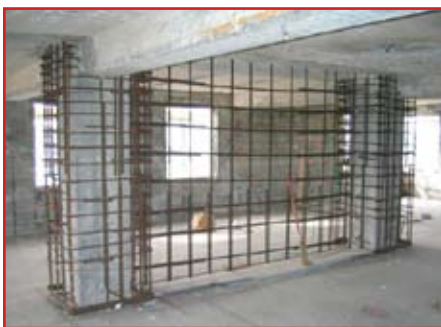
Figure 2: Original retrofit scheme required new shear walls and enlargement of existing columns.

To bring the building to current seismic design code requirements, traditional retrofit measures were undertaken consisting of construction of new exterior and interior concrete shear walls and the placement

of structural steel shapes along the entire height of the building.

The retrofit was begun, and the shear walls were completed up to the 4th floor (Figure 2). The majority of the foundation retrofit was also completed, but the funds dwindled and the project was stopped. It was at this point that alternate retrofit options were reviewed.

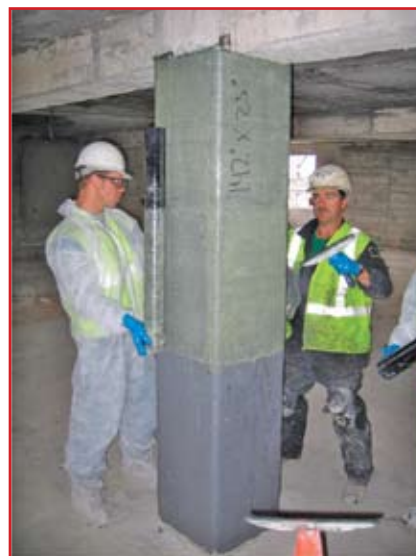
Figure 3: Confinement of a typical interior column with FRP.

Unidirectional glass FRP fabrics were applied to all columns to provide a confining effect to the concrete, which increased its effective compressive strength and ductility. This eliminated the need to increase column size or to add steel reinforcement to existing columns. The fabric was supplied in 24-inch wide tapes that were wrapped around the column in at least two layers. Along the height of the column, the bands of fabric were continued by butt joints (Figure 3, see page 35).

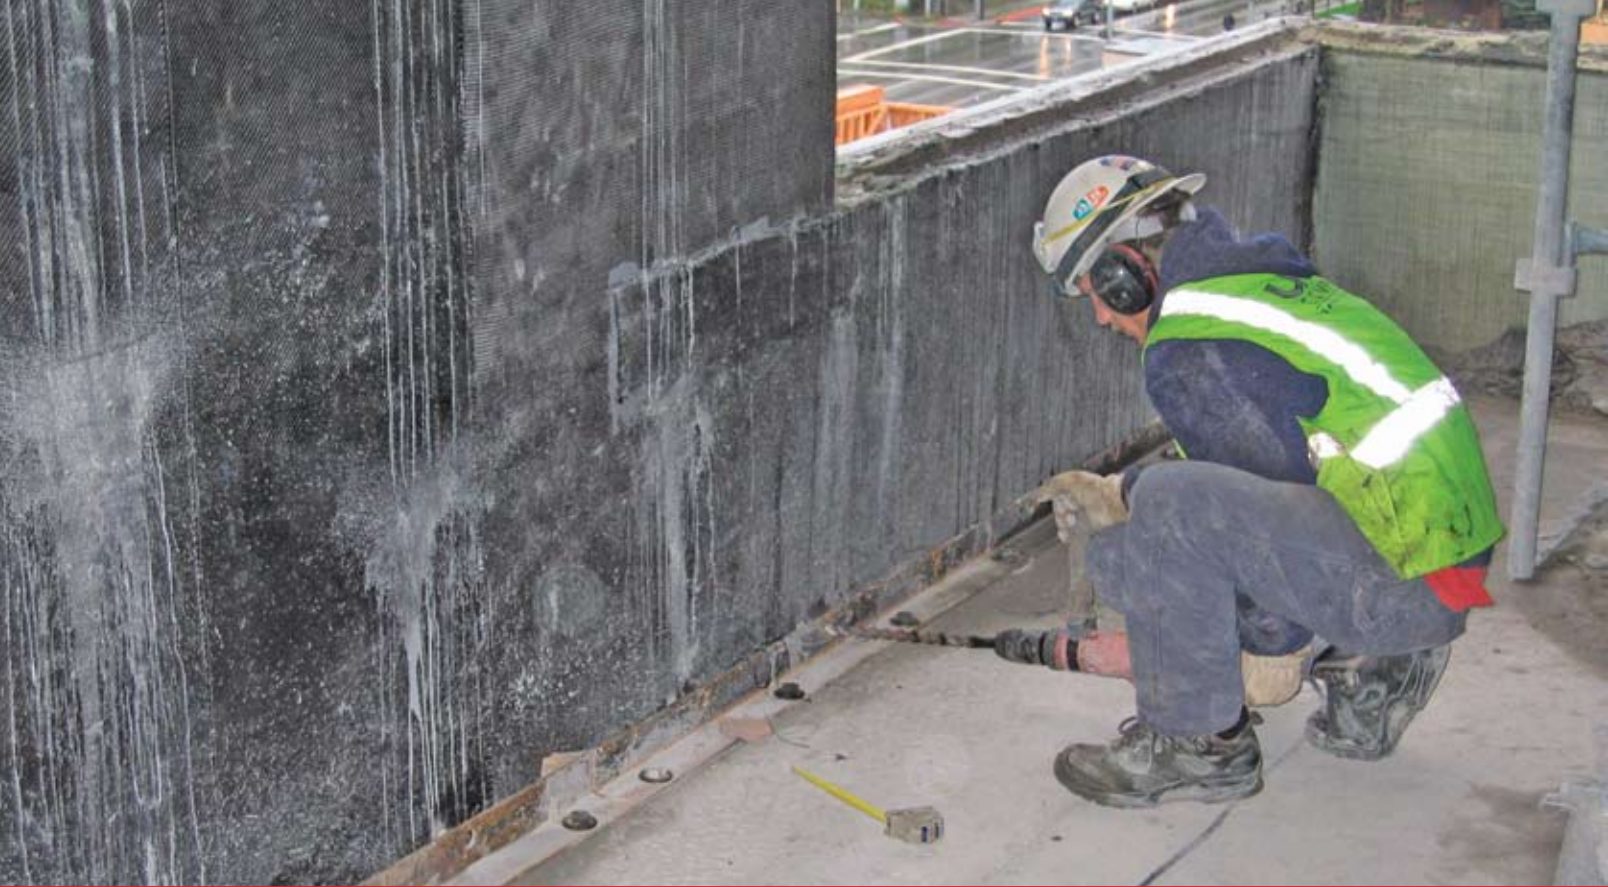
Figure 4: Retrofit of walls with carbon fabric and connection of wall to floor.

The north and south side bearing walls above the 4th floor were converted to shear walls by applying biaxial carbon FRP on the inside face of the wall up to the 9th floor. Vertically oriented unidirectional glass fabric was placed between the 9th and 10th floor. Additional horizontally oriented unidirectional glass fabric was applied on the end of the new exterior shear wall constructed up to the 4th floor. Specialized structural details were developed to ensure proper load transfer to the floor system at each level (Figure 4).

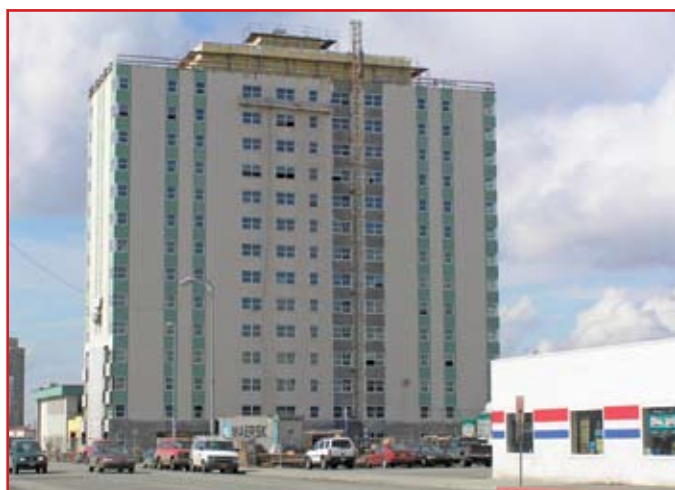
Figure 5: View of nearly-completed and painted building.
