**North American Society for Trenchless Technology (NASTT)
NASTT's 2016 No-Dig Show**

TM1-T1-02

Carbon FRP Breathes Life into 90-Years Old Riveted Steel Penstock

Mo Ehsani, PipeMedic, LLC, Tucson, AZ
Craig Hurley, Salt River Project, Phoenix, AZ
Joshua Ahumada, FRP Construction, LLC, Tucson, AZ

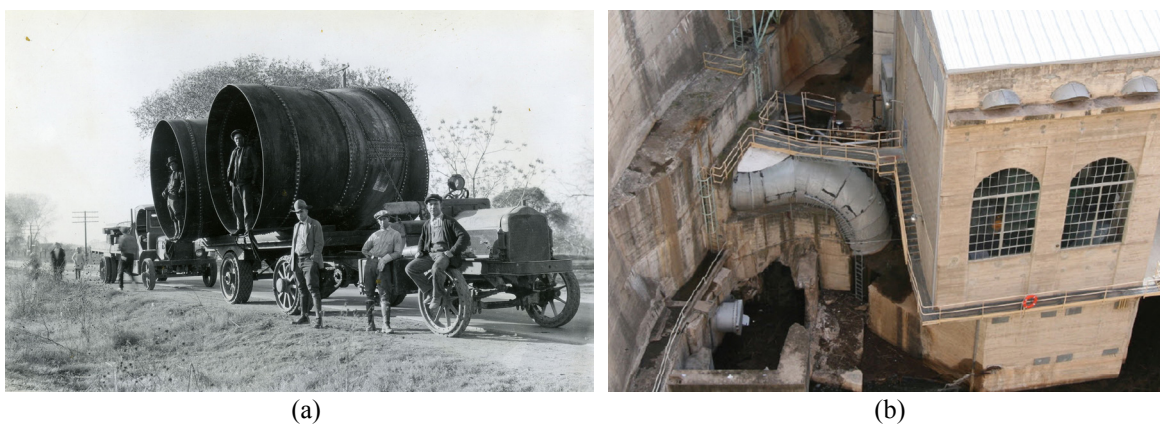
The two 96-inch diameter riveted steel penstocks were assembled off site and shipped to the job site Fig. 2(a). As shown in Fig. 2(b), these two pipes deliver the water from the dam to a single 120-inch diameter riveted pipe through a complex geometry. At the Y-connection, the 120-inch pipe drops in elevation by 20 feet before turning into a 90-degree elbow. This complicated geometry not only made the original construction difficult, it would also limit the options available for repair of the penstock as mentioned later in the paper.

Fig. 2. The riveted penstock: (a) being transported to the dam c. 1925 and (b) in service.
