**North American Society for Trenchless Technology (NASTT)
NASTT's 2016 No-Dig Show**

TM1-T1-02

Carbon FRP Breathes Life into 90-Years Old Riveted Steel Penstock

Mo Ehsani, PipeMedic, LLC, Tucson, AZ
Craig Hurley, Salt River Project, Phoenix, AZ
Joshua Ahumada, FRP Construction, LLC, Tucson, AZ

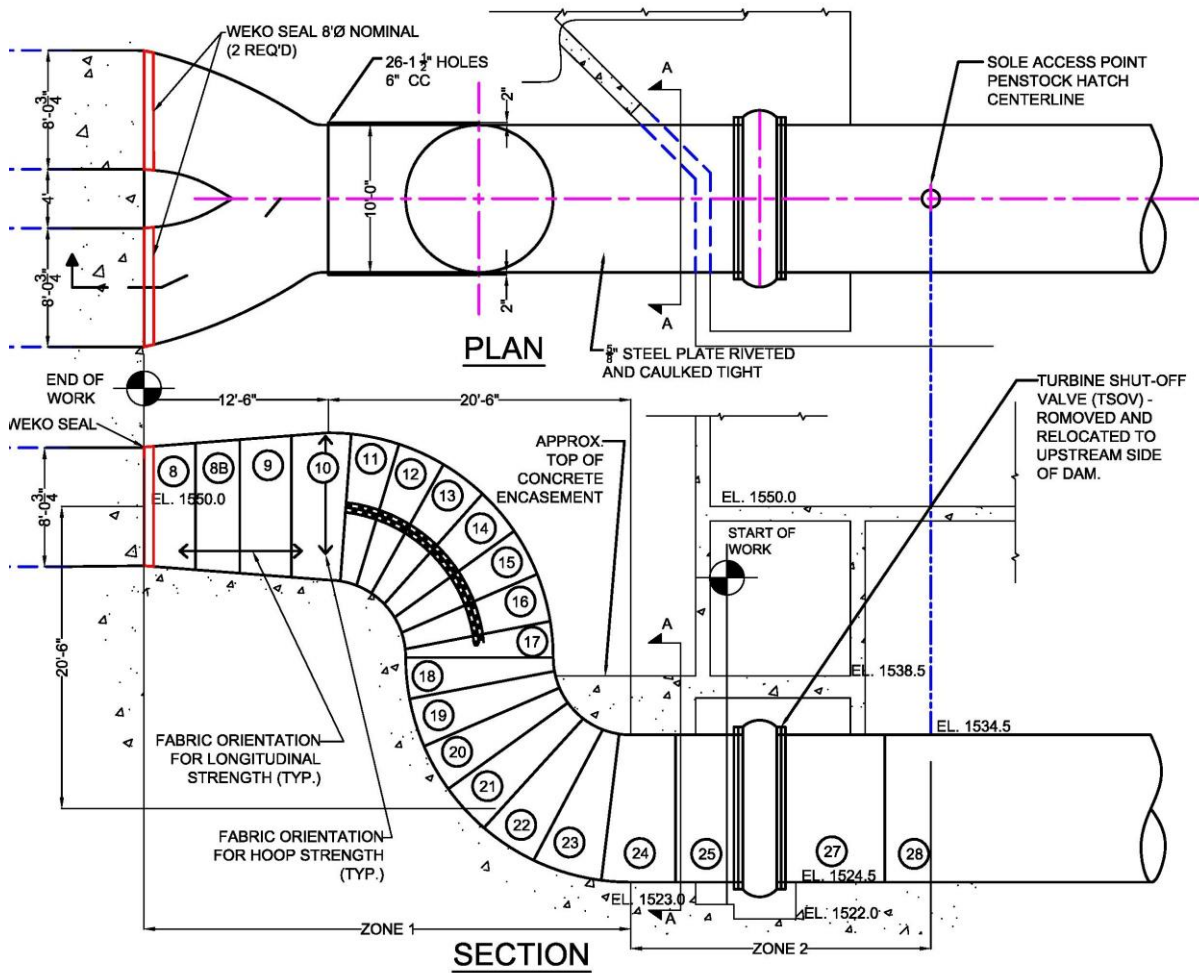
Fig. 6. Overall repair area

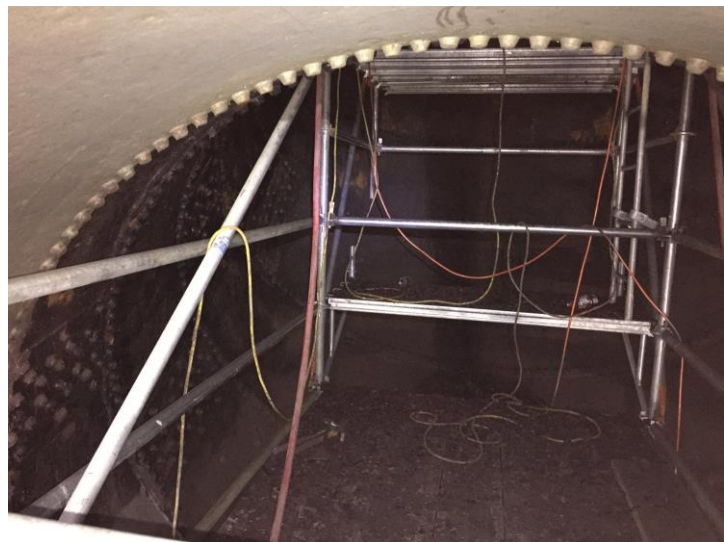
Ring scaffolding was used so that individual pieces could be lowered into the penstock and assembled into a custom unit. The penstock itself had significant change in elevation. Scaffolding was set up in the lower pipe that would reach the entire circumference of the penstock by hand (Fig. 9).

Fig. 9. Scaffolding set up inside the penstock.
