North American Society for Trenchless Technology (NASTT)
NASTT's 2018 No-Dig Show

MM-T1-04

Corrugated City of Steam – Emergency Repair of the Drama Tunnel

Mo Ehsani, Professor Emeritus of Civil Eng., U. of Arizona, and President, QuakeWrap, Inc.,
Tucson, AZ USA

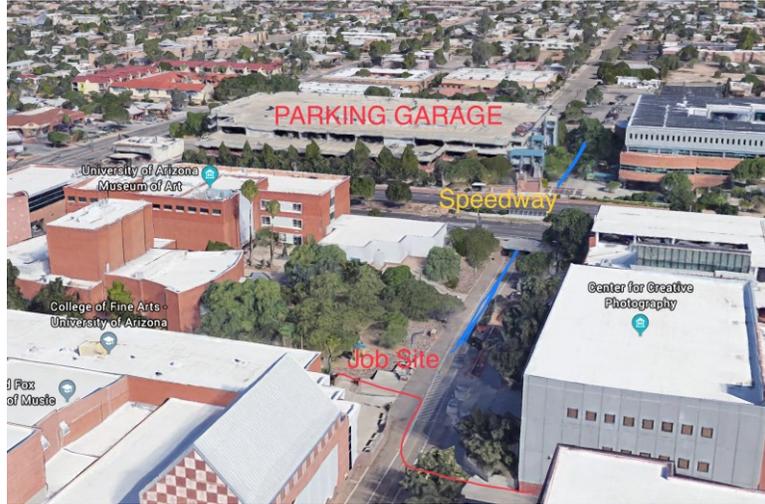
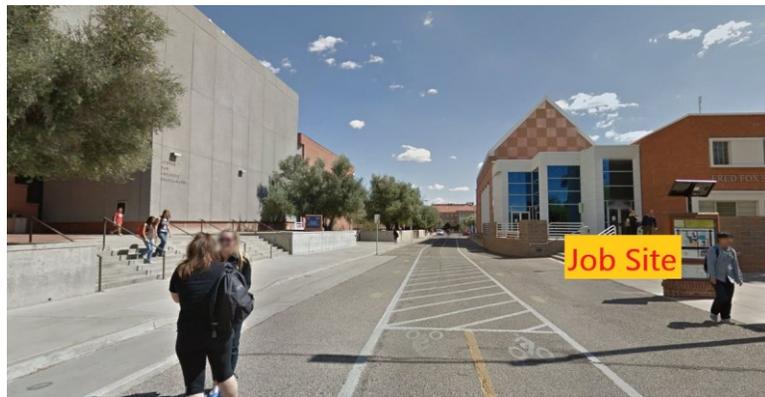
This project is located at a very busy area of the campus with significant pedestrian traffic. Figure 2(a) shows a view of the campus looking north. Speedway Blvd. is a major thoroughfare in Tucson that runs in the east-west direction through the campus. On the north side of the boulevard are many structures such as a large parking garage that is used by commuters and the business school. In addition, many student apartment buildings are located on the north side of Speedway. Every day thousands of people walk through the Speedway underpass (shown by a blue line in Fig. 2a) to access the main campus. Figure 2(b) shows the view looking south as one exists the underpass below Speedway Blvd. The tunnel is in front of the School of Theatre, Film and Television, formerly known as Drama School, thus the name Drama Tunnel.

Fig. 2. Project site location and access.
